Chrysler Drivetrain Alignment Prevents CV Pop-Out

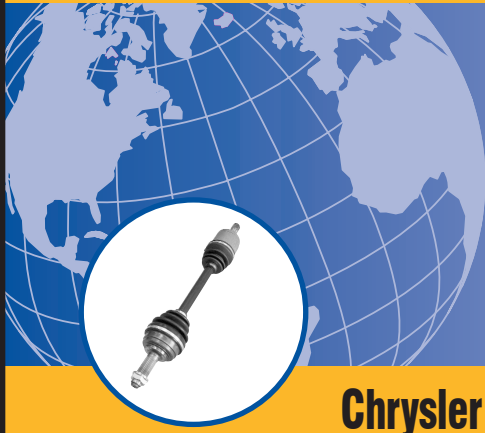
Vibration, inner joint pulling out of the transaxle or catastrophic axle failure, leaving the vehicle dead in its tracks (especially Chrysler products).

Drivetrain alignment out of specifications caused by:

- Defective or maladjusted engine mounts
- Missing or loose mounting hardware
- Front end damage

Equal length axles: With the vehicle on the ground, measure the distance from the small boot clamp on the outer joint to the large boot clamp on the inner joint. If unequal, loosen the engine/trans mount bolts and adjust the drivetrain until both measurements are equal.

Different length axles: Remove the nuts from both axles. Push axle towards the transmission and bottom out the inner joint. Measure the distance the stub shaft has moved into the hub. Repeat for the other shaft and compare the measurements. If unequal, loosen the engine/trans mount bolts and adjust the drivetrain until both measurements are equal.
