NAPA Tech TIPS

Nissan Optical Distributor Test

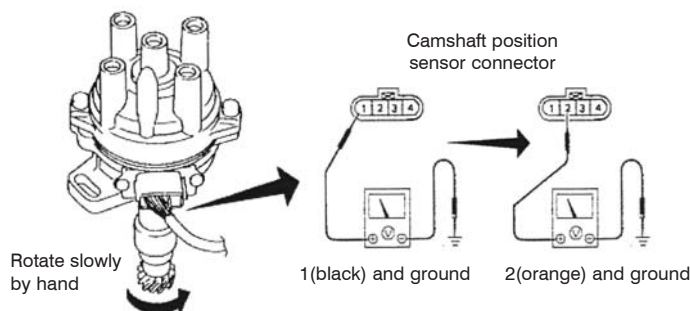
1. Test power transistor & coil. Refer to service manual for specific test procedures.
2. Check ECC fuse and/or fusible link at fusebox.
3. Check ECC relay, typically a black/white wire, for 12v.
4. Check for 12v at distributor; typically an orange wire, pin 2.
5. Check continuity of all wiring going to and from computer, transistor and distributor.
6. To test optical sensor in the distributor, remove distributor cap and remove the distributor but leave the harness to the sensor connected. Turn ignition switch on (**DO NOT START ENGINE**). Rotate distributor shaft slowly by hand and check voltage between terminals 1(black) and ground and then between terminal 2(orange) and ground. Measure voltage on 12v DC scale; it should fluctuate between 0 and 5 volts DC.
