# Preventing ABS sensor failure in pigtail style hub assemblies

TT 08-019

June 2008

## Tech Tip

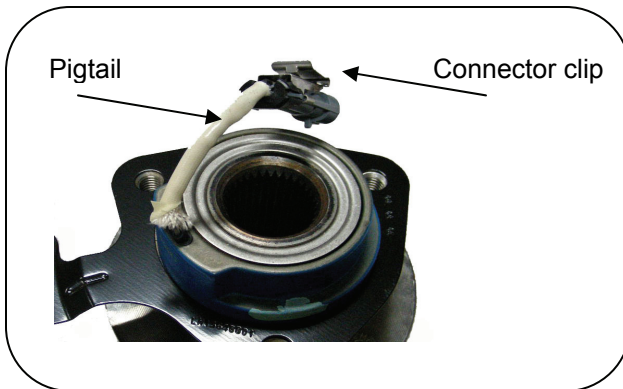
Figure 1

**Figure 1** shows a typical pigtail style hub assembly with backing plate. This style is most common to GM vehicles. The arrows in the figure are pointing to the ABS pigtail and pigtail connector clip. The clip may be metal or plastic.

- After removal of old hub unit make sure the steering knuckle is clean from rust. Excessive rust can lead to improper seating of hub assembly.
- During installation make sure the pigtail connector is routed correctly and not pinched in the knuckle.
- The connector clip must be completely seated on the backing plate. Failure to seat the clip will cause excessive movement in the pigtail wiring and internal damage will occur. The connector must also be properly secured to the harness connector.
- Make sure the weather pack has not fallen out of the harness. Replace if missing. Without the weather pack, water intrusion will occur damaging both the ABS sensor on the hub and the harness side wiring and connector.
- During the final installation process make sure the axle nut is torqued correctly.

**Note: Incorrect torque can damage the sensor cap and allow for water intrusion. Incorrect torque will also cause premature bearing failure.**
