NAPA Tech TIPS

2005-06 Ford Escape/Mercury Mariner ECM Problem

XTP-81044F for 2005-2006 Ford Escape and Mercury Mariner 2WD 3.0L

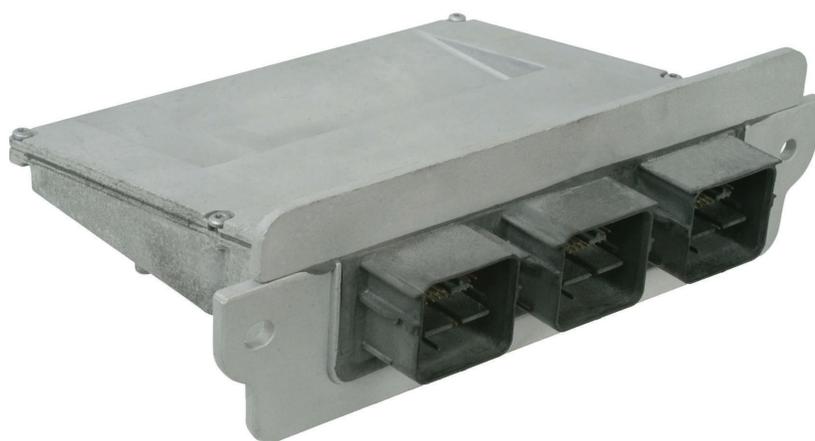
Excessive RF output from the original design Coil-On-Plug (COP) units damages the PCM.

Before installing and operating the replacement Powertrain Control Module (PCM), please refer to Ford Technical Service Bulletin (TSB) 10-18-10. Ford warns that radio frequency (RF) interference from the spark plugs may have led to failure of one or more coil-on-plug (COP) ignition coils and the original PCM. All COP ignition coils must be replaced, as specified in the TSB, to prevent damage to the replacement PCM. Superseded Ford TSB 09-2-6 required spark plug replacement. The replacement COP referenced in the new TSB was redesigned with additional RF suppression, eliminating the need to change plugs while also protecting PCM.
