## **Safety Notice**

### **SCBA Universal Air Connection (UAC) and Quick-Fill® Hose Fittings**

June 10, 2016

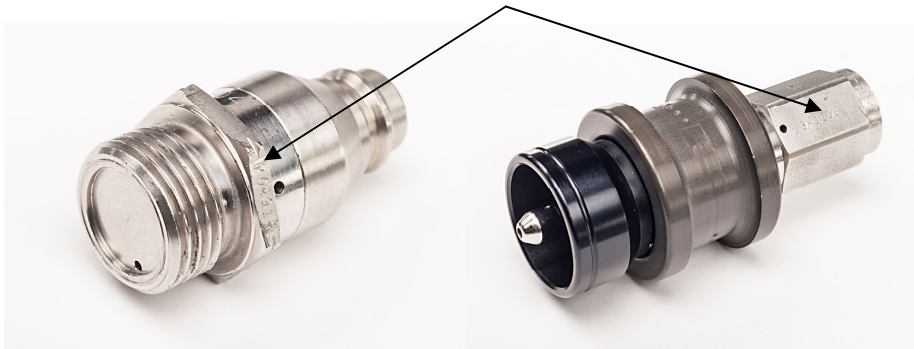
Affected fittings can be identified by Eaton's date code, which is marked on the fitting (see photos below). The first three digits of the date code are in Julian Date format for the specified year, which is indicated by the next two digits. For example, a fitting that is marked "060 15" would have been manufactured on March 1, 2015. If the date code on the fitting has six digits, read the first five digits.

- **Male Fitting** – MSA part number 485070, Eaton part number FD17-1082-10-04, Julian Date Codes – 060 15 through 243 15 (manufactured March 1, 2015 through August 31, 2015).
- **Female Fitting** – MSA part number 485071, Eaton part number FD17-1003-04-04, Julian Date Codes – 060 15 through 365 15 and 001 16 through 031 16 (manufactured March 1, 2015 through January 31, 2016).

Eaton's Date Code in Julian Date format is stamped on hex.  
Example: 060 15 (March 1, 2015)

**MSA is replacing all male UAC and female Quick-Fill fittings within the Eaton affected date range provided below. If you have any affected fittings, follow the steps provided in the Temporary Use of Affected Fittings section below and contact your local MSA Fire Service Distributor to arrange for installation of replacement fittings as soon as possible.**
