## Safety Advisory

### FL4000H and MSIR Flame Detectors

August 1st, 2017

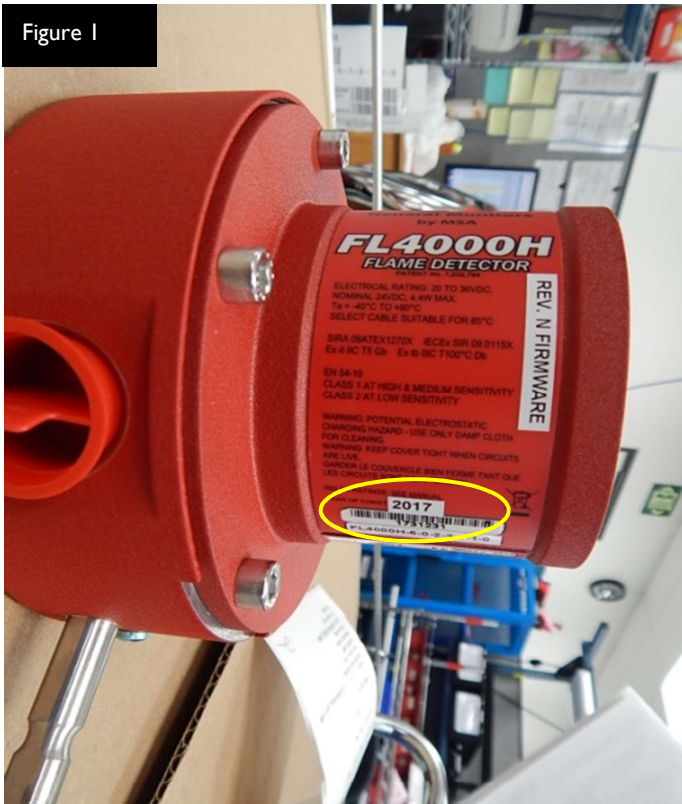
Units that could potentially exhibit this condition include FL4000H and MSIR Flame Detectors (both General Monitors and MSA brands) containing firmware versions “J” through “M” as indicated on the flame detector label. These detectors were manufactured between 2008 and 2016. Flame detectors with firmware version “N” or later include upgraded firmware that will prevent the occurrence of this condition. Figure 1 shows an example of the year of manufacture located on the detector. Figure 2 shows an example of the firmware revision label located on the detector.
