# **User Safety Notice**

M1 SCBA Hose Crimp

June, 2023
PLEASE READ NOW AND TAKE ACTION

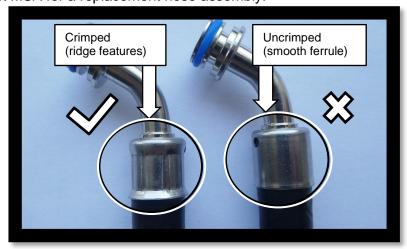
Figure 1 – Hose Crimp Geometry
Page 1 of 4

During assembly operations, MSA identified a small number of instances of medium pressure hoses with uncrimped hose connections. Our records indicate that you purchased one or more units manufactured prior to May 8th, 2023, and this inspection is to verify the proper hose crimping on the medium pressure hoses of the SCBA. Although it is unlikely that a unit in use would exhibit this condition, confirmation of correct assembly is needed.

The inspection must be performed on your entire stock prior to next use and is to verify the proper crimping of the medium pressure hoses of your SCBA. Appearance and geometry of crimped and uncrimped hose ferrules are shown in Figure 1.

- 1. Visually inspect each end of the potentially affected hose assemblies to confirm the ferrules of the hose fittings have been crimped.
- 2. If any end is not crimped, remove the unit from service, isolate in quarantine, and contact MSA for a replacement hose assembly.

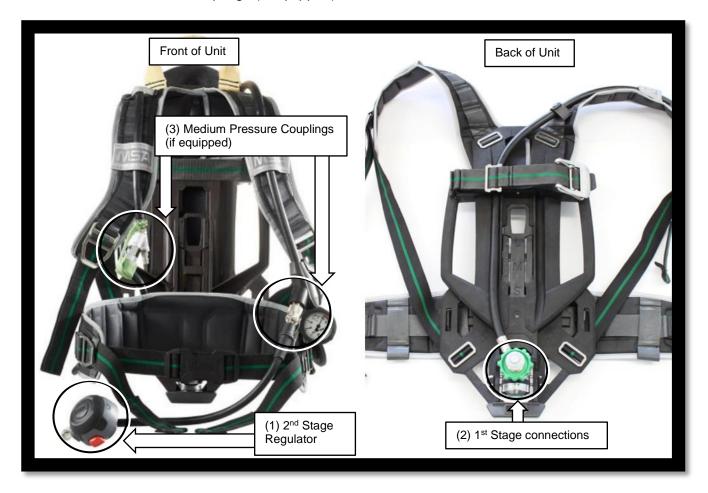
Figure 2 – M1 SCBA Inspection Locations

The M1 is a modular system, with many available configurations. Depending on unit configuration, your unit may not have all of the connections shown in Figure 2, and may vary in appearance. Inspection needs to be conducted on the following 3 areas of the unit:

- 1. 2<sup>nd</sup> Stage Regulator (LGDV) Hose Assembly
- 2. 1st Stage Regulator Connections
- 3. Medium Pressure Couplings (if equipped)

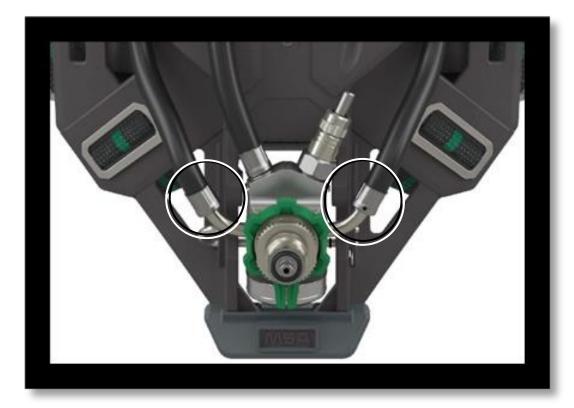
Figure 4 – 1<sup>st</sup> Stage Connection Inspection

- 2. 1st Stage Connections (Figure 4)
  - a. Quantity of side port connections varies with configuration. Inspect all side port connections that are present.
