## **User Safety Notice**

### **Male Quick Connect Fitting Replacement Program for ExtendAire™ I/II and RescueAire™ II Systems**

April 2, 2014

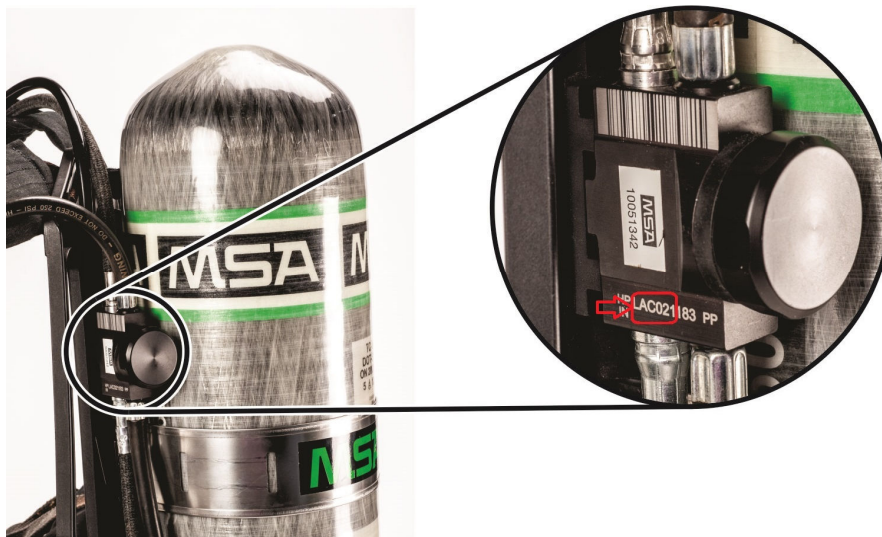
Air Mask Serial Number Location – Refer to First Six Digits

Refer to the photos below to locate the first stage regulator serial number.
