SERVICE AND APPLICATION NOTES

100046

April 20, 2022

LRP16HP Residential Package Units – 9-Pin Relay Mis-Wiring Issue

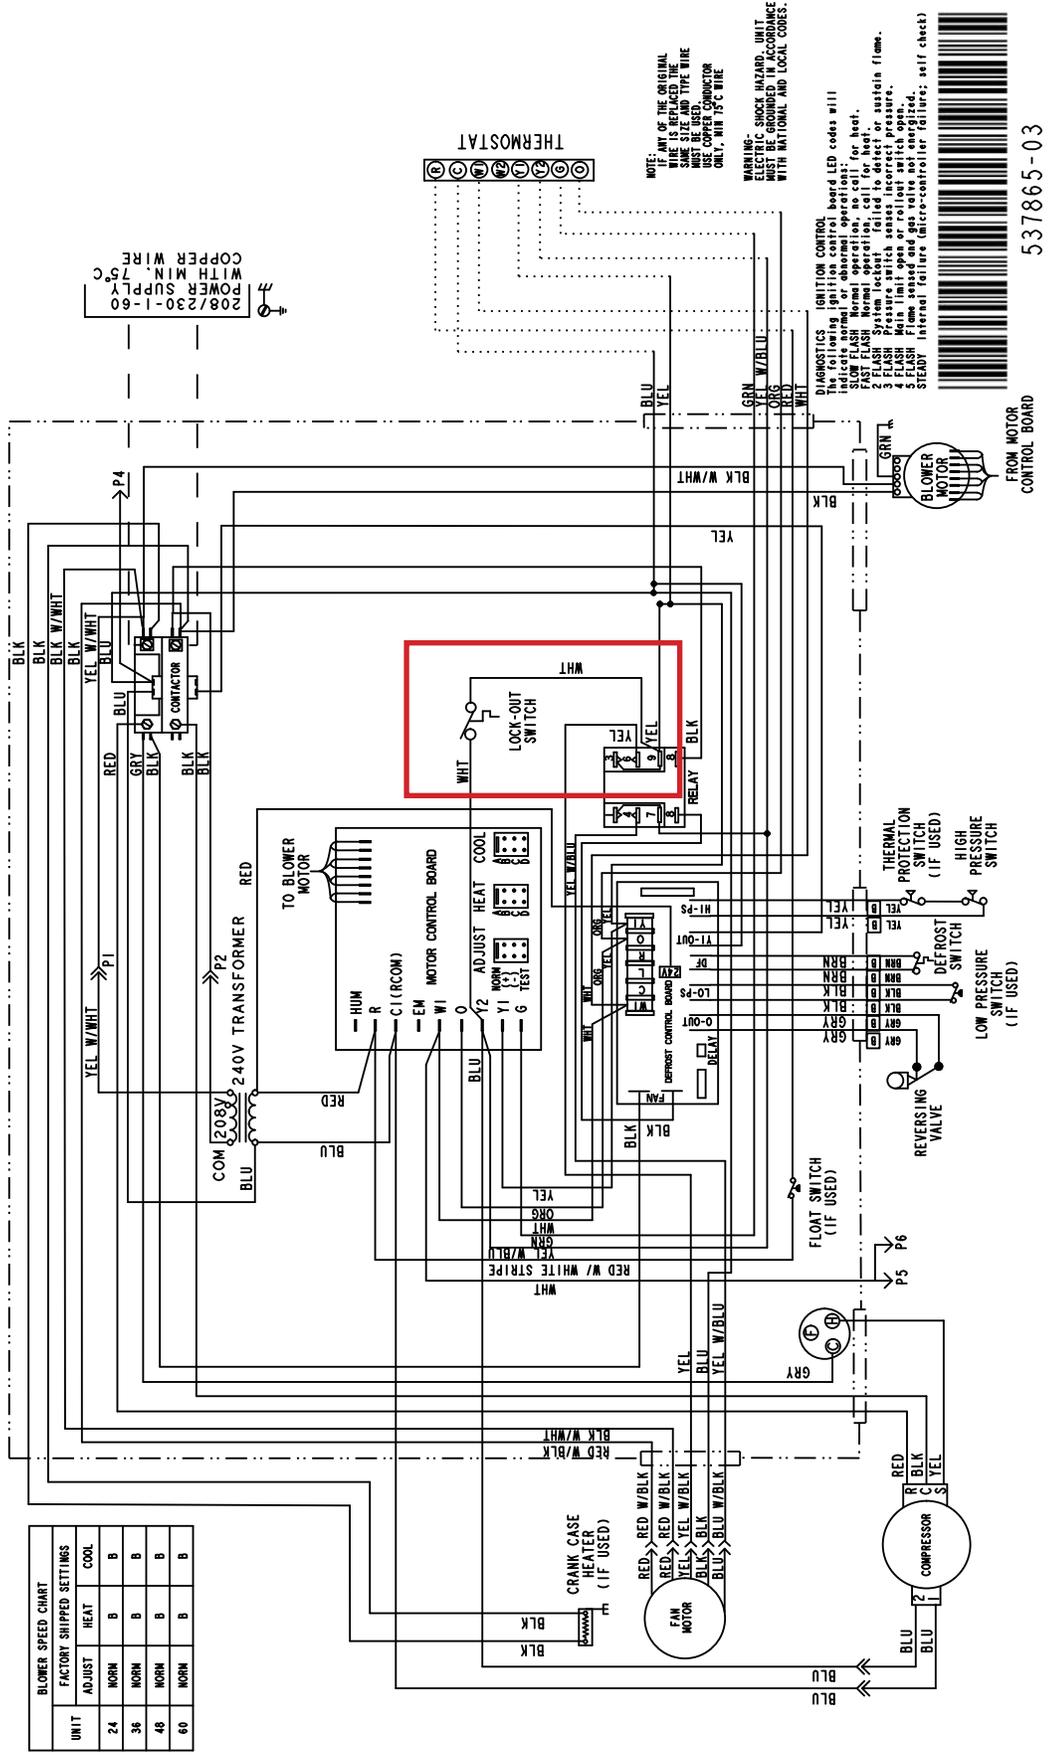
Field / Factory Correction Wiring

There have been some field reports of the clear 9-pin defrost relay being mis-wired from the factory, with the yellow wires reversed on pins # 6 and # 9 in relation to the white two-stage wire attached to pin # 9.

This will cause the outdoor condenser fan to stay on during defrost, and does not allow the second stage to lock in.

To correct the issue, the factory will move the white lock-in switch wire from pin 9 on the defrost relay to the 24V 'hot' side of the compressor contactor. This will be the same connection point on the contactor as the yellow "Y1-OUT" wire that originates from the defrost control.

For units already installed, the field can cut off the 3/16" spade terminal from the white wire and install a 1/4" spade terminal and install it on the compressor contactor 24V 'hot' terminal with yellow wire Y1 out that comes from the defrost board.
