User Safety Notice

M1 SCBA Catch spring/Retainer PR18 Pressure Reducer

April, 2023

PS23006

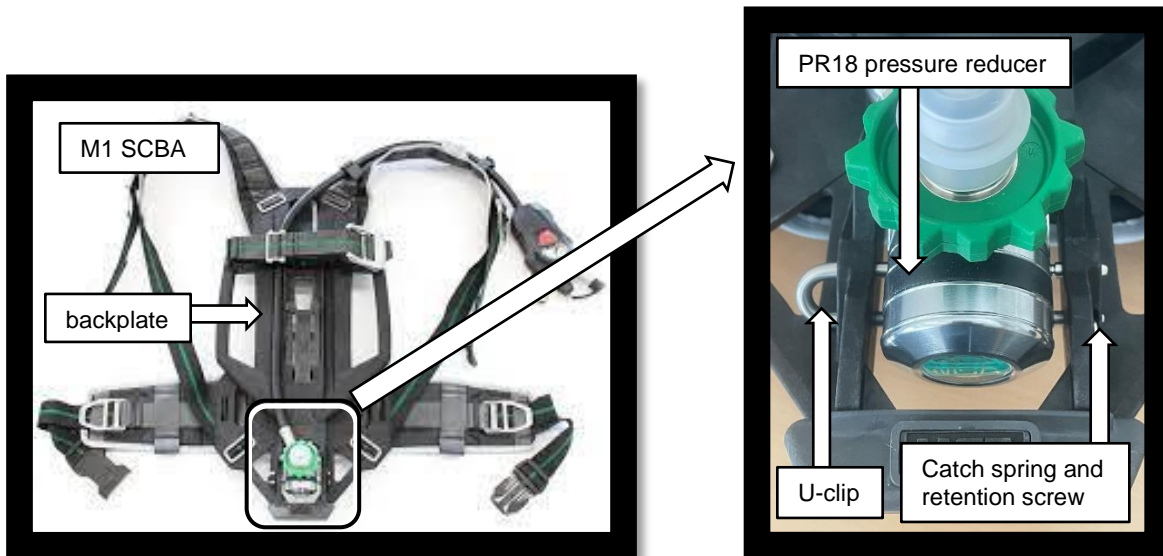
Figure 1 – M1 SCBA and PR18 Pressure Reducer

MSA is issuing this User Safety Notice to inform you of an inspection procedure to verify the proper operation and function of the U-clip and catch spring used to retain the PR18 Pressure Reducer of the MSA M1 SCBA (figure 1).

MSA has received a report from a customer that recently found isolated instances of a missing retention screw and a deformed catch spring. The PR18 pressure reducer is secured to the backplate by a U-clip, which is held in place by the catch spring when the catch spring is properly attached to the backplate via the retention screw. If the retention screw is missing, or catch spring is deformed, there is potential for the U-clip to disengage, allowing the reducer to move, which can lead to disconnection of the medium pressure line, and exposure of the user to the surrounding environment. **MSA has not received any reports of injuries associated with this condition. However, it is necessary that you stop use and perform the actions outlined in this notice.**

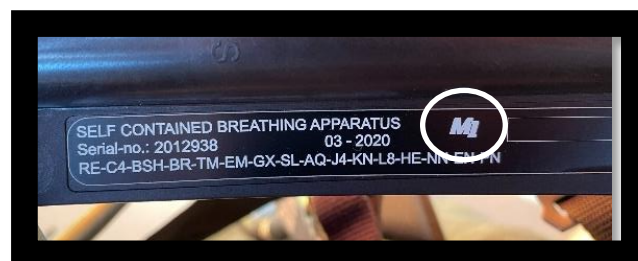
Figure 2 – Product Label

If you are unsure if your unit is an M1, reference the product label found on the backplate of the unit (figure 2)
