Inspection Notice

MSA Latchways® Guided Type Fall Arrester
February 2024
PLEASE READ AND TAKE ACTION NOW

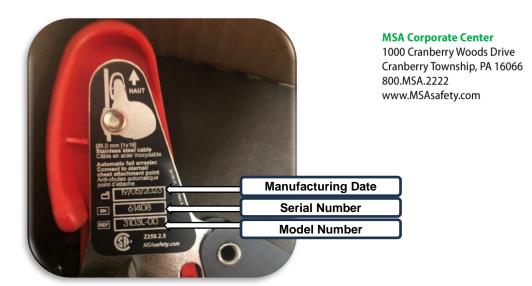
Figure 2: GTFA Inspection Data

- 1) Confirm Model Number and Manufacturing Date Refer to Figure 2
 - a. Model Number
 - i. Confirm that your model number is listed in Table 1.
 - ii. If your model number is not listed, no further action is needed.
 - b. Manufacturing Date
 - i. Confirm that your manufacturing date is between 16/02/2021 and 30/01/2024
 - ii. If the date is outside of this range, no further action is needed.

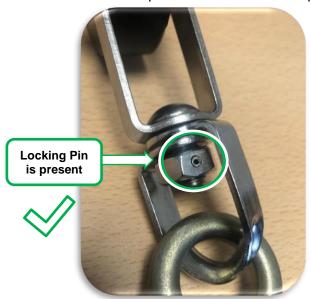
Figure 3: Locking Pin is Present

- 2) **Inspect the product** Visually inspect the swivel connector of the unit for the presence of the silver locking pin.
 - a. Locking pin is present (Figure 3) no further action is needed.
 - b. Locking pin is not present (Figure 4) remove the product from service and follow the procedure below for a replacement unit.

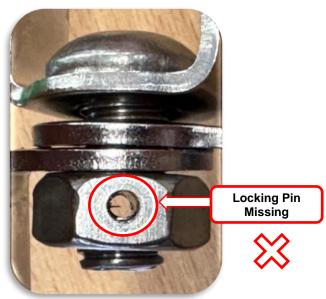
Figure 4: Locking Pin Missing

MSA has received a field report of an MSA Latchways GTFA that did not have a locking pin in the nut of the swivel connector between the carabiner and main body of the unit. Without this locking pin in place, there is potential for the connection to come loose during operation.

To receive a replacement free of charge for affected units, please scan the QR code 1000 Cranberry Woods Drive and complete the GTFA Replacement Form. You may submit multiple forms if more Cranberry Township, PA 16066 800.MSA.2222 than one model is affected.
