User Safety Reminder

Air Mask Audi-Larm[™] Coupling Nut

March 8, 2012

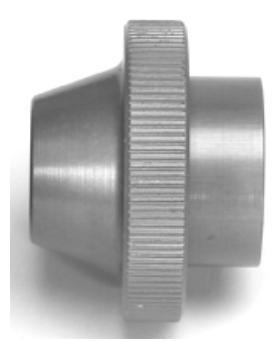
2000 - 2004 Design

The connection between the cylinder valve assembly and MSA SCBA's Audi-Larm Handtite Coupling Nut Assembly is a critical air pressure boundary that must be inspected, maintained and reassembled in accordance with MSA's SCBA Operation and Instruction Manuals. Failure to perform the tasks identified in this User Safety Reminder may result in a rapid, unexpected release of high pressure air from the Air Mask Audi-Larm coupling nut joint. The coupling nut secures the Audi-Larm assembly to the cylinder valve, employing a urethane o-ring seal. Failure to adequately tighten the coupling nut handwheel may result in a loosening of the coupling nut that can result in extrusion of the o-ring, resulting in rapid air loss.

MSA reminds users to ensure that all three designs (pictured below)

of Audi-Larm coupling nut handwheels must be inspected during each cylinder change or prior to each SCBA use to:

- 1. Ensure there is a sealing o-ring present on the CGA insert and that it is not damaged, deformed or discolored. If the sealing o-ring exhibits any of these signs, replace the sealing o-ring before installing a replacement cylinder.
- 2. Inspect all threads on the CGA Handtite and cylinder valve for contamination and / or damaged threads. If there are any signs of

contamination on the coupling nut or cylinder threads, clean the threads before attempting to connect the two assemblies. Any indication of damage to either component's threads, the damaged component must be removed from service.

- 3. When connecting the CGA handtite coupling nut to the cylinder valve, if any binding occurs while threading the two assemblies' together, stop and disassemble the two components. Inspect all threads for damage or contamination. Any component with damaged threads must be removed from service until that component is either repaired or replaced. If signs of contamination are present, clean the threads thoroughly and re-connect the two assemblies.
- 4. Before pressurizing the SCBA, ensure the CGA handwheel assembly is tightened, hand-tight to the cylinder valve after 1) replacing a cylinder or 2) after a SCBA has been in storage (i.e. in a truck's walkaway bracket or a SCBA carrying case).
