# Excessive wheel flange runout can lead to brake pulsation

TT 10-003

March 2010

## Tech tip

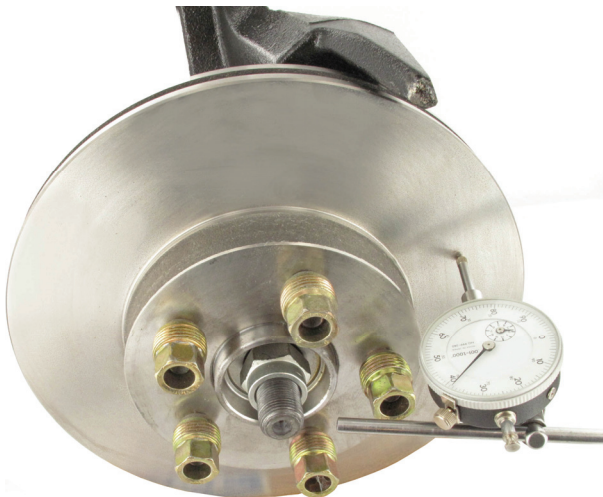
with the rotor mounted on the hub unit, should not exceed 80 microns. Some value line hubs can reach or exceed this limit just on the flange face itself, not considering the contribution to runout that also comes from the rotor. Therefore brake disc runout on assemblies utilizing value line hubs may be up to 5 times the recommended maximum when they are brand new! You may also have to spend additional time indexing the hub and rotor trying to eliminate DTV.

*Fig. 1 Rotor runout*

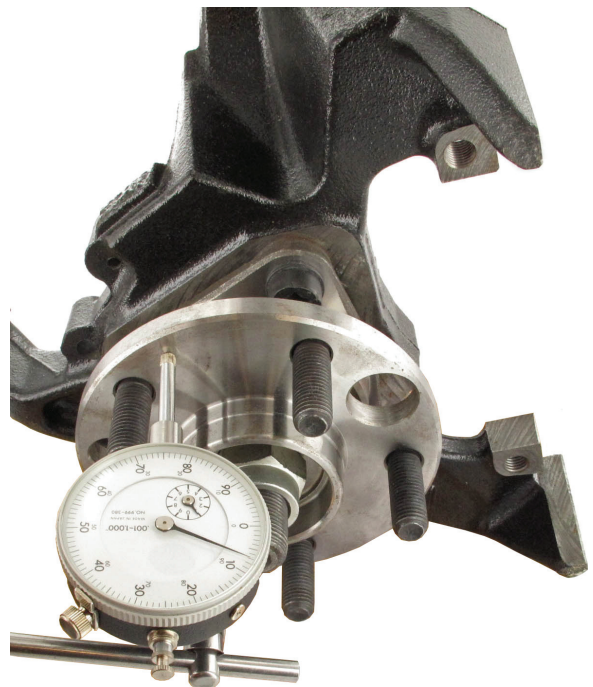
Because the components of the vehicle work together, a poorly manufactured hub assembly could be the cause of the DTV. Rotor runout measurements and wheel flange runout should be checked to insure the quality of both components. See Fig 1 and 2. The rotor runout relies on the interface of the rotor and hub assembly. Typical rotor runout, as measured

*Fig. 2 Wheel flange runout*
