Repair Procedure for Environ™ Coil System All-Aluminum Coils

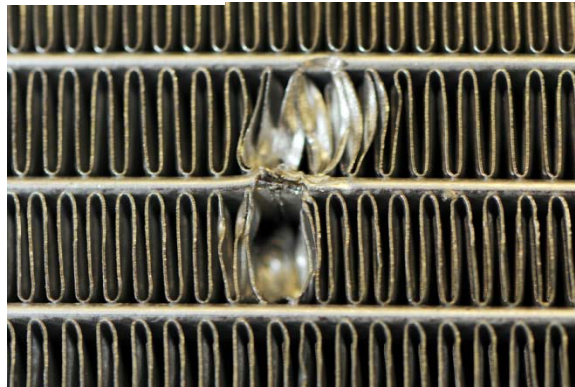
Figure 1

1. Turn power off using the lock out/tag out procedure and install gauge manifold on the unit suction and discharge lines.
2. Locate the damaged area (see Figure 1) and verify the leak site using industry standard leak detection practices. Note: Due to its recessed fin pack, the Environ all-aluminum coil's tube construction is capable of withstanding mild impact, provided the impact is not sharp and does not cut into the tube.

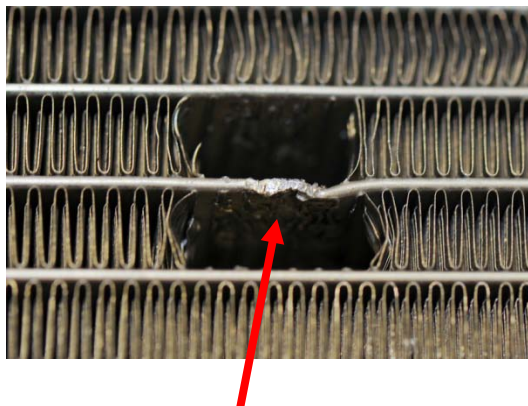
Figure 3

Damaged area to be repaired

Use long needle-nose pliers to remove the fins by grabbing them and slowly tearing the fin away from the tube above and below the tube needing repair (see Figure 2). Do not remove the fins more than approximately 1 inch on either side of the repair location (see Figure 3).
