# Tech TIPS

## Don't Reuse Torque-type CV Axle Nuts

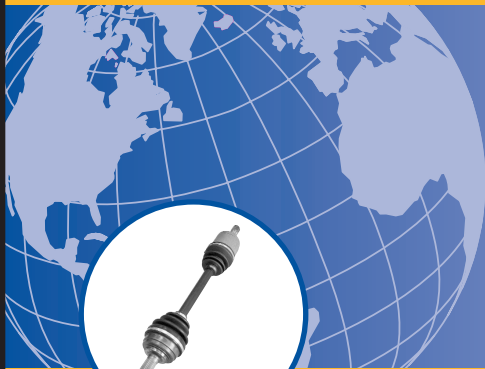
Outer Constant Velocity stub shaft has movement in and out with resulting clunking and damage to the outer joint.

Reuse of retaining nut of a prevailing torque type.

Prevailing torque-type nut

**Do Not Reuse**

Discard old retaining torque-type nut and always use a new one.
