# NAPA Tech TIPS

## Operating Wiper Motor Before Installation Causes Problems

**Application:** All Electric Wiper Motors.

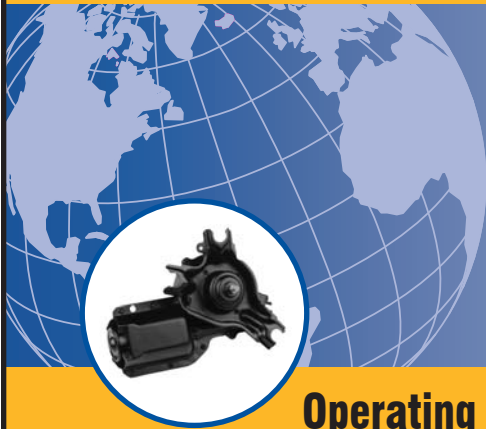
**Problem:** Replacement wiper motor parks in wrong position.

**Cause:** Power was applied to the unit before installation moving it off park position.

**Solution:** Remove linkage from installed unit, operate motor on high speed for 5 seconds, then switch to park position. Reinstall linkage so wiper arms are in park position. Operate unit and test for proper operation. If not correct, test motor ground (see Tech Tip TT 40-0001), also refer to vehicle service manual for specific installation procedures.

**Note:** NAPA units are supplied in the correct park position.
