FireHawk[®] M7XT Audi-Larm[™] Audible Alarm

MAINTENANCE AND REPAIR

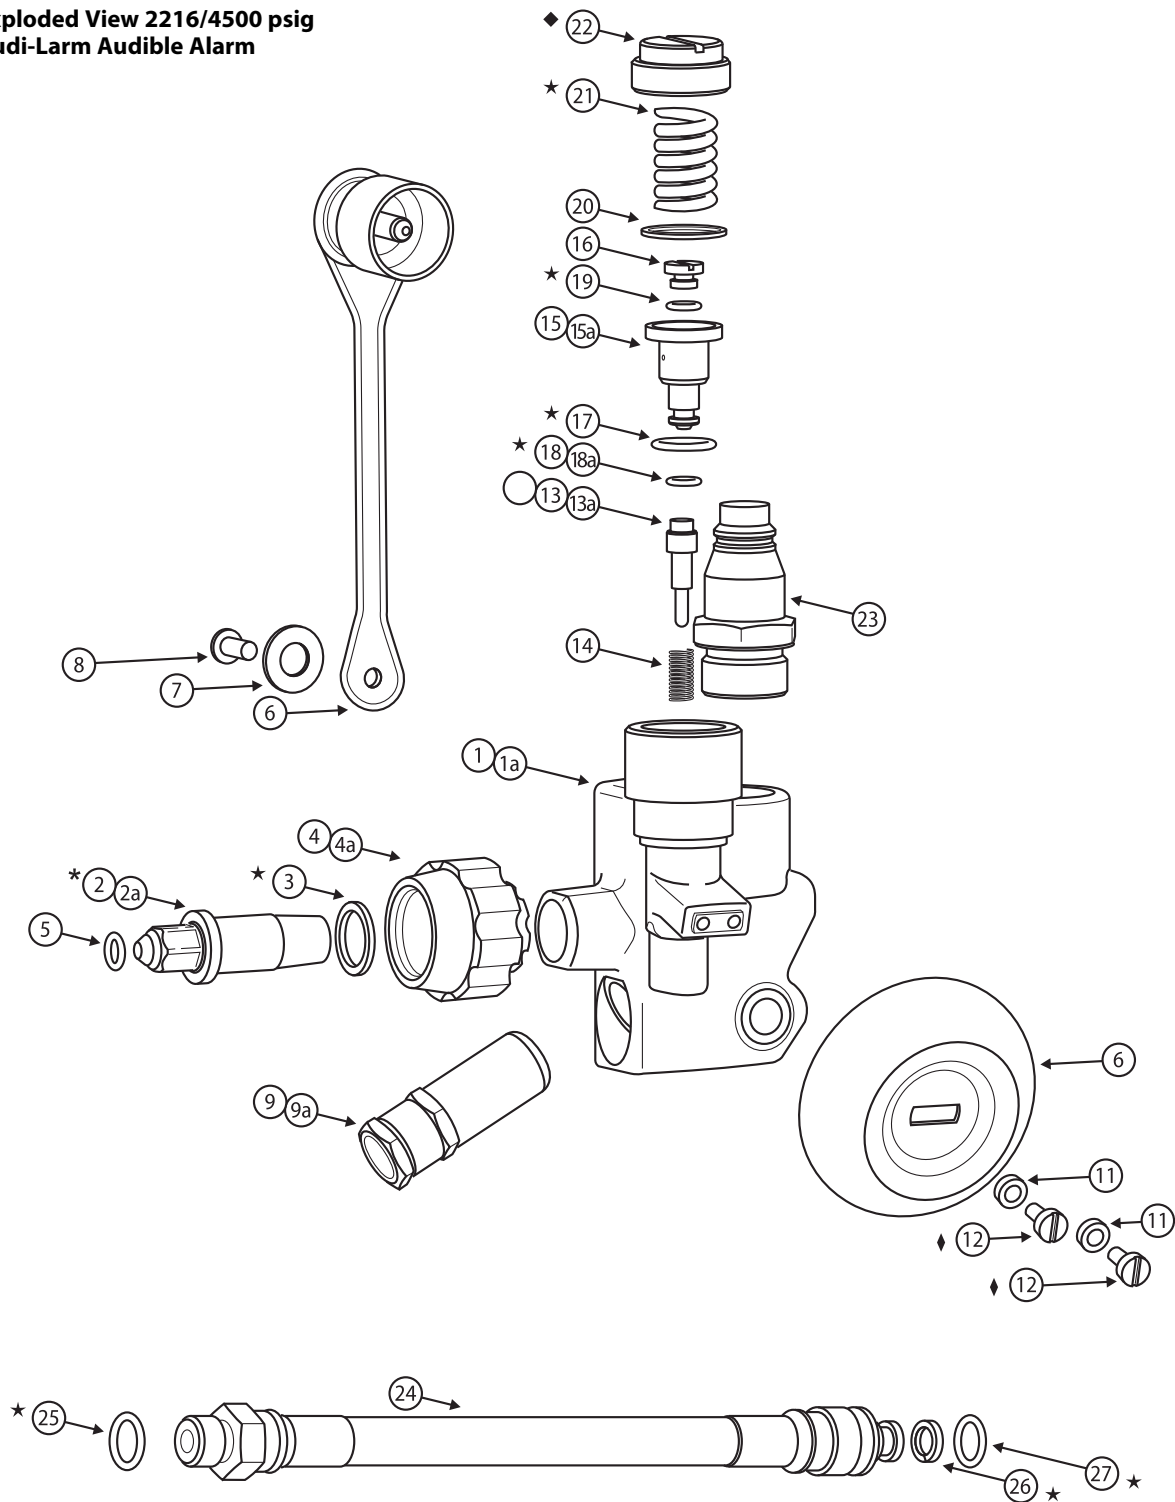
Exploded View 2216/4500 psig
Audi-Larm Audible Alarm

Item	P / N	Description
1	10038417-SP	Audi-Larm Body, 2216 psi
1a	10144916-SP	Audi-Larm Body, 4500 psi
2	10062086	Fitting, Nipple, 2216 psi
2a	10062087	Fitting, Nipple, 4500 psi
3	93031	Washer, CGA Nut
4	10120808	Coupling Nut, 2216 psi
4a	10120809	Coupling Nut, 4500 psi
5	10052355	Nipple O-ring
6	10038031	Dust Cover Assembly
7	10041962	Washer
8	10037952	Screw
9	10036291	Pressure Relief Valve*, 4500 psi
9a	10036292	Pressure Relief Valve*, 2216 psi
10	485829	Bell
11	54197	Lock Washer (2)
12	635245	Screw, #8-32 x 7/16
13	10044574	Striker with Pellet, 2216 psi
13a	10144918	Striker with Pellet, 4500 psi
14	85055	Striker Spring
15	85049-SP	Piston Assembly, 2216 psi
15a	10144917-SP	Piston Assembly, 4500 psi
16	85052	Piston Plug
17	635953	Piston Bore O-ring
18	635954	Piston Nose O-ring, 2216 psi
18a	635553	Piston Nose O-ring, 4500 psi
19	66395	Piston Plug O-ring
20	68523	Retaining Ring
21	474352	Spring, Adjuster
22	10143901	Adjuster Nut, Black

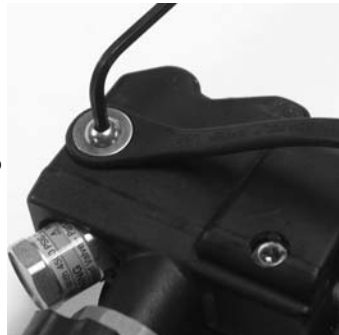
1. Use a 1/8" hex wrench to remove the screw.

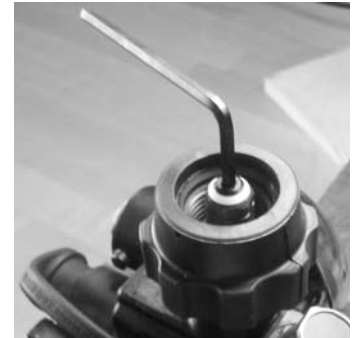
1. Using a 1/8" hex wrench, loosen the CGATip (P/N 10124808). Set aside.

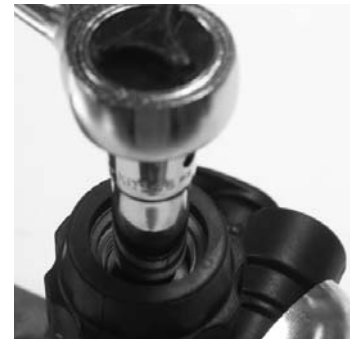
- b. Use a 7/16" deep-well socket to unscrew the nipple.

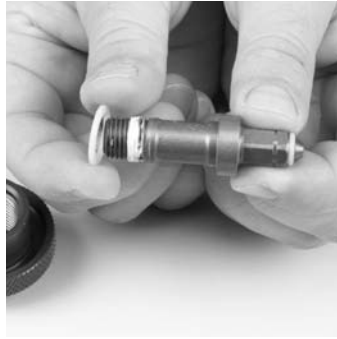
d. Remove the washer.

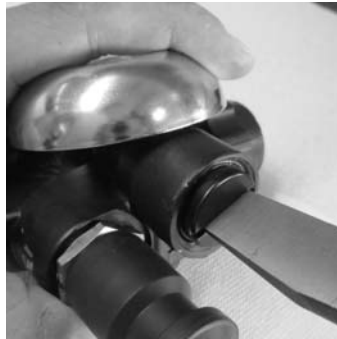
2. Use a large flat-blade screwdriver to remove the adjusting screw.

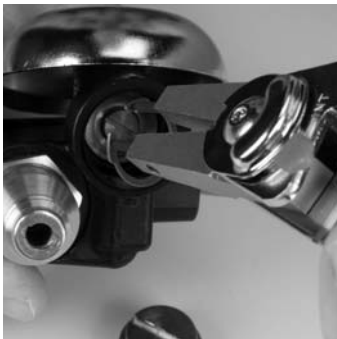
4. Use retaining-ring pliers to remove the ring. Apply only enough pressure to remove the ring.

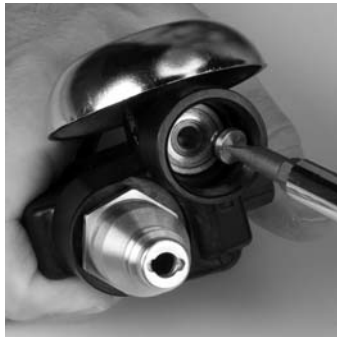
5. Unscrew and remove the piston plug and o-ring.

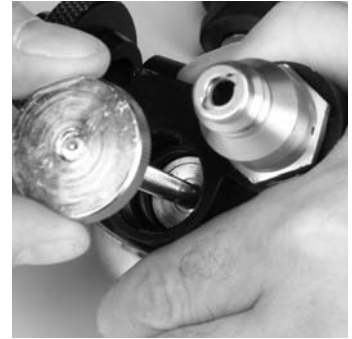
6. Screw the extraction tool (P/N 482426) into the back of the piston.

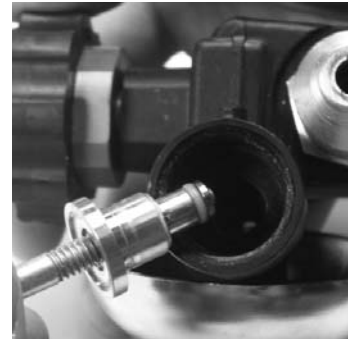
7. Remove the piston by gently rocking and pulling the extraction tool.

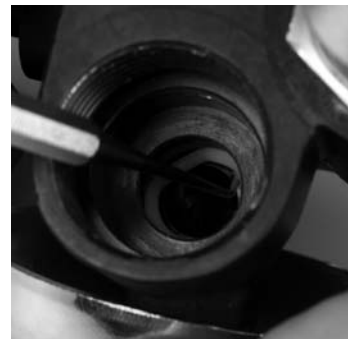
12. Remove and discard the o-ring beneath the alarm housing shoulder.

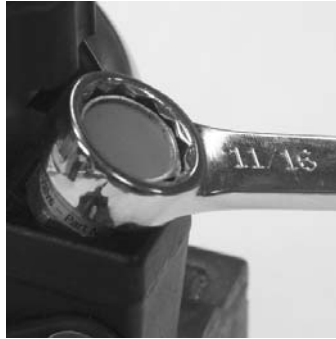
1. Use an **11/16" wrench** to loosen and remove the relief valve.

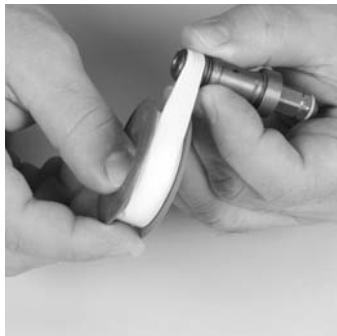
- a. Apply Teflon tape to the nipple thread.

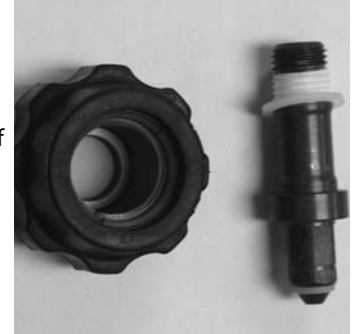
3. Slide the new washer onto the threaded end of the nipple.

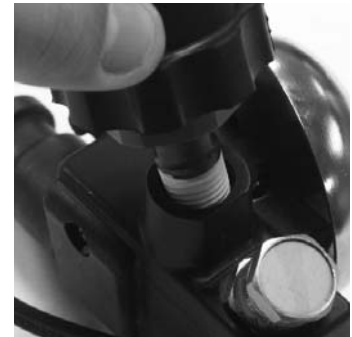
- a. Screw the coupling nut and nipple into the Audi-Larm body.

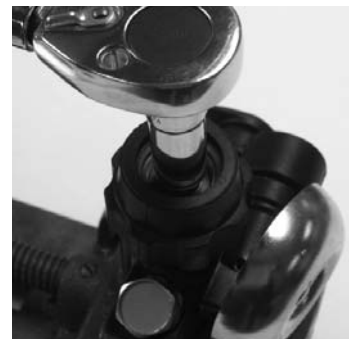
- b. Use a torque wrench and **7/16" deep well socket** to tighten the nipple to **15 ft lbs.**

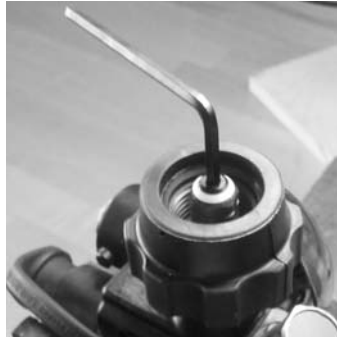
2. Using a 1/8" hex wrench, tighten the tip until threads bottom out.

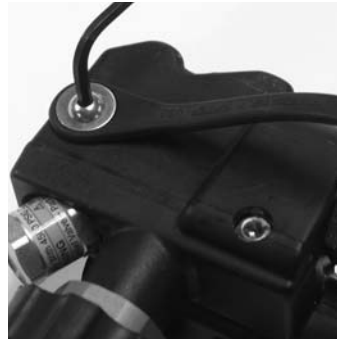
1. Insert screw with washer through tether into Audi-Larm body.

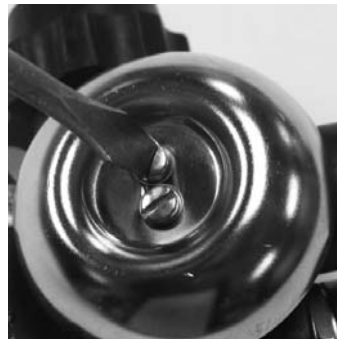
1. Align the bell with the boss on the alarm housing. The rim of the bell must not touch the alarm housing.
2. Apply one drop of Loctite 271 (P/N 26875) into each hole.
3. Insert screws with lock-washers (P/N 54197) into the Audi-Larm body and tighten.

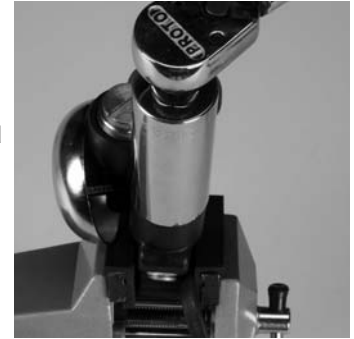
2. Screw the coupling into the alarm body by hand.

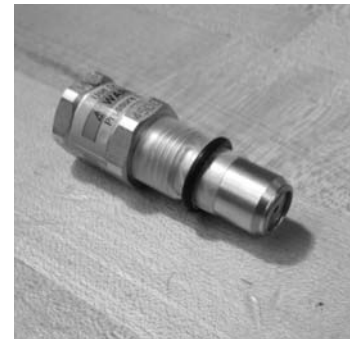
- c. Slide the o-ring over the threads.

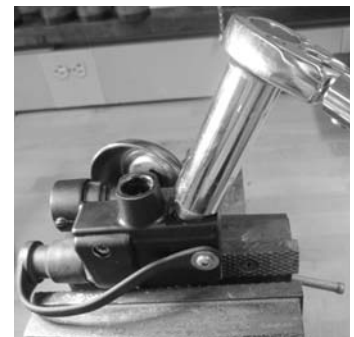
4. Using a torque wrench and 1 1/16" socket tighten to 200-250 in. lbs.

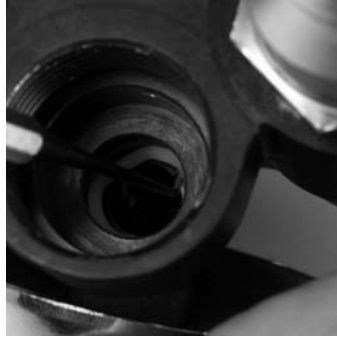
1. Install the o-ring under the shoulder inside the alarm housing. Use the o-ring removal tool to push the o-ring into place.

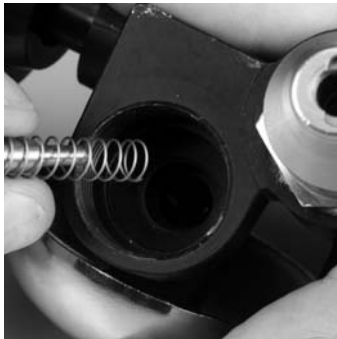
2. Apply a small amount of Silicone Lubricant (P/N 494992) to the striker shaft.
3. Place the spring over the striker.

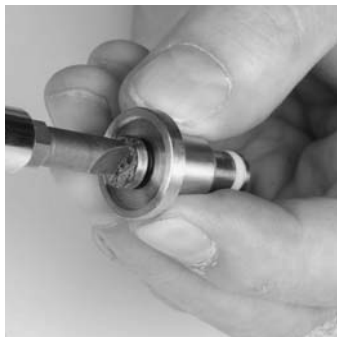
5. Ensure that the striker extends through the hole and can touch the bell.
6. Install new o-rings on the piston and the piston plug.

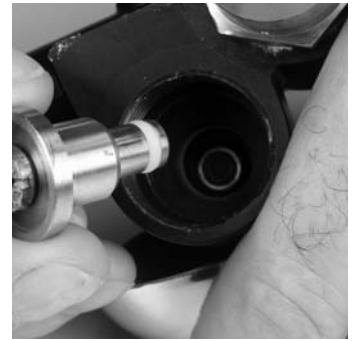
9. Insert the piston into the alarm housing and press it into place.

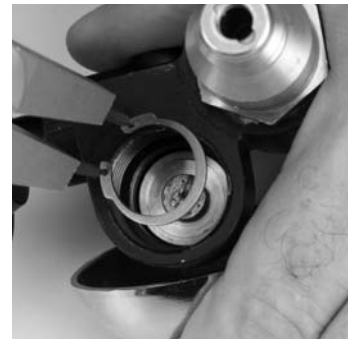
10. Use retaining-ring pliers to install the new retaining ring flat side out.

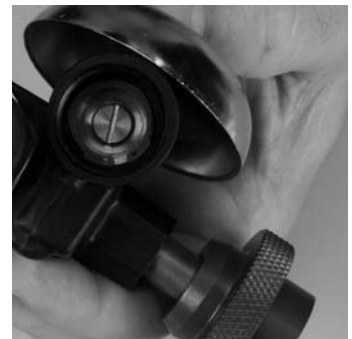
NOTE: The ring must seat in the groove located about 1/16" above the piston. Use the o-ring removal tool if necessary to push the ring into the groove. If the ring is bent, or does not fit tightly, replace it.

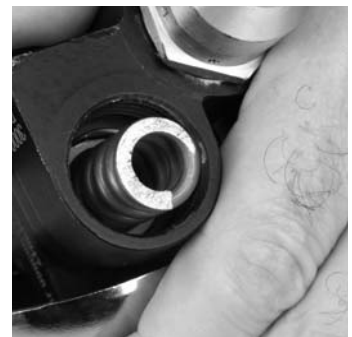
12. Insert the adjusting spring into the alarm housing.

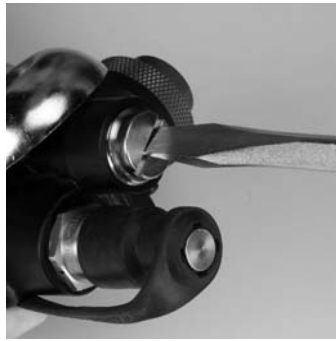
13. Insert the screw into the alarm housing and tighten about 1-1/2 turns.
