UAC/Quick-Fill Coupler Inspection Procedure

MSA is pleased to offer a new inspection procedure for all male UAC/Quick Fill Couplers. This new inspection procedure is offered as a result of MSA's Continuous Improvement activities in which MSA regularly implements enhancements to products and procedures.

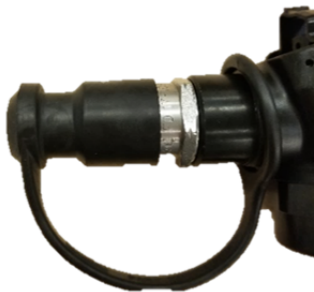
Figure 4

- a. If there is difficulty with the dust pin assembly being inserted and/or it does not fully sit into the UAC/Quick-Fill coupler as seen in Figure 4, record as a fitting needing action.

Condition	Criteria	Inspection Observation
Proper Functionality	No Air Leak	No audible leak when dust pin is pressed
Action Needed	Unable to Fully Seat Dust Pin	Visually observed in Figure 4. Expected leak if test can be performed.
	Repeatable Hissing	Continuous hissing after two test attempts with resealing of the dust pin assembly between tests.
	Significant Burst/Air Leak	Audible air leaking continuously when the dust pin is pressed.

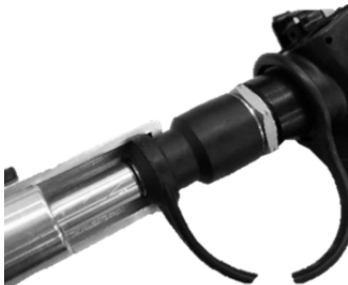
3. Using the tool (PN 10197862), align the tool as shown in Figure 5 with the lip against dust pin assembly cover.

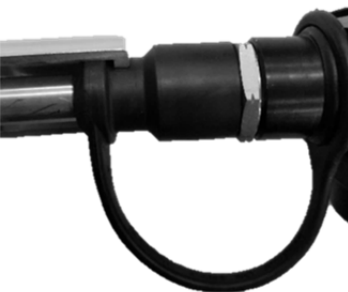
Figure 6

4. Press the tool firmly against the dust pin assembly until one can feel it depress into the coupler or the dust cover meets the hex body of the coupler, as shown in Figure 6.
