Product Information News

February 15, 2013

URC PRESSURE RELIEF VALVE

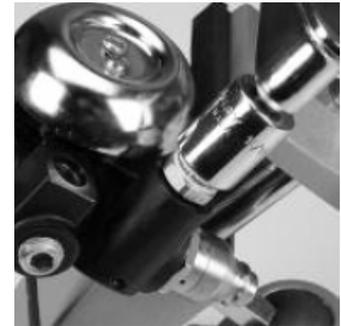
1. Inspect relief valve for physical damage
 - a. If damage is evident or the label is missing on the relief valve, install a new relief valve.
2. Install a new O-ring (P/N 632736)
 - a. Temporarily apply tape to the threads, so that the O-ring is not damaged, slide the new O-ring into place.
 - b. Apply a small amount of Christo-Lube Lubricant to the O-ring.
3. Screw the relief valve into the alarm body and hand tighten.
4. Use a torque wrench and 6 point 11/16" socket to tighten the relief valve to 200-250 in. lbs.

NOTE: Be careful not to cross-thread the relief valve.

5. Leak test the assembly with Snoop liquid leak detector solution P/N 600920, or equivalent, to ensure the system is leak tight.
