User Notice
AirFrame™ Carrier & Harness Assembly
used on Firehawk™ Air Masks

January 31, 2005

How to identify the AirFrame Carrier and determine if it requires this retrofit:

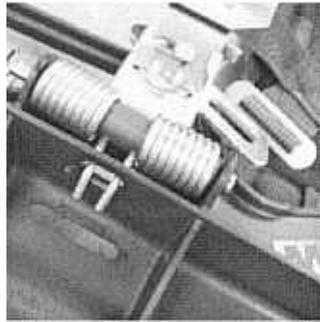
Figure B

If the slot in the carrier is wide enough so that the two spring ends near the cylinder band latch are separated or could become separated, the carrier requires this retrofit. These carriers were manufactured from May 2004 through December 2004.

We have determined that if the slot in the carrier permits the two spring ends near the cylinder band latch to separate (see Figure B), the cylinder retaining band can become loose. To correct this condition, we are making available a special lock-washer to users of affected AirFrame Carrier & Harness Assemblies. The lock-washer requires no special tools or training for installation and when properly installed, the washer will prevent the two spring ends from separating. This User Notice applies to AirFrame Carriers manufactured from May 2004 through December 2004 only. AirFrame Carriers manufactured after December 2004 include a narrower slot that holds the spring ends together (see Figure C) and requires no retrofit.

If your carrier requires this retrofit, contact MSA Customer Service at 1-877-MSA-3473 and obtain the appropriate number of lock-washers (P/N 10062951) and install as follows:

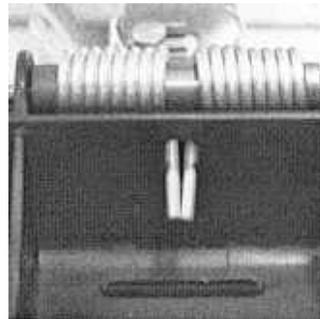
Figure C

If the slot in the carrier is narrow so that the two spring ends near the cylinder band latch can not separate, this retrofit is not required. These carriers were manufactured after December 2004.
