## MSA Carabiners

The purpose of this letter is to provide a detailed explanation regarding the machined groove on the gates of some MSA locking carabiners.

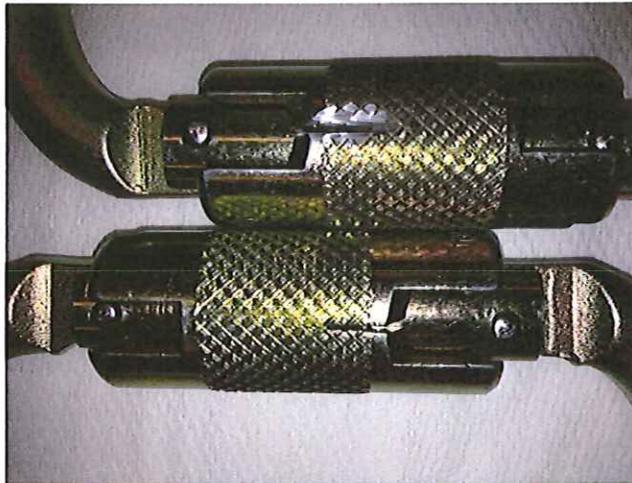
The attached picture shows two of the same type of carabiner (P/N 10089207). The bottom gate is normal. The top one has had some of the knurling ground off in order to show the full width of the machined slot.

These carabiners are designed to be self-closing and self-locking. These features are controlled with internal springs. The slot shown in this picture is intentionally machined into the barrel of the gate to provide an attachment point for the spring that controls the rotation of the barrel.

The barrel also has a knurled, or checkered pattern, machined into it. This creates a rough edge to the machined slot that anchors the internal spring. We have received some questions about the visual appearance of this slot and whether it is actually a crack. As explained above, the appearance is the result of a machined surface and is typical of many different carabiners.
