# Inspection tips for the Scotseal® PlusXL wheel seal

TT 09-009

July 2009

## Tech tip

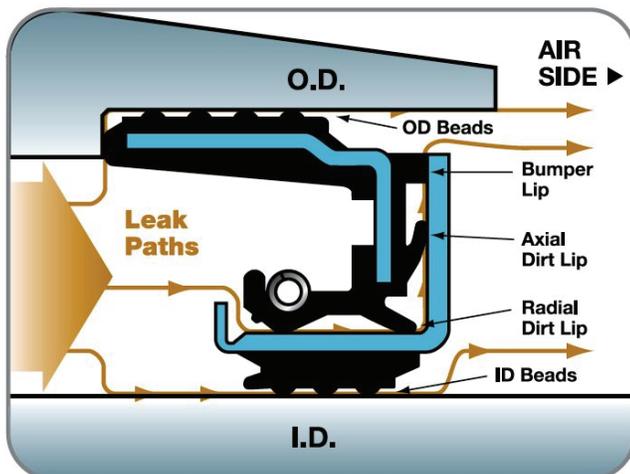
The cross sectional drawing to the left illustrates the critical components of the Scotseal PlusXL, showing how the seal functions and its potential leak paths.

Most Scotseal PlusXL wheel seal failures are a result of:

- Improper installation
- O.D and/or I.D. not lubed
- Lube contamination
- Spindle not fully prepped
- Use of a hammer

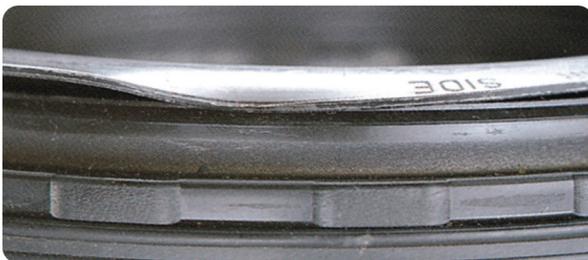
One of the most common types of failure is a dented sleeve assembly, which can result from a number of problems during installation.

**Dented, scarred sleeve assembly:** This may be caused by improper installation preparations such as not lubricating the I.D. and O.D. of the seal, a poorly prepared hub, or the use of hard-faced tools or seal driver. **Remember:** the Scotseal PlusXL is hand installable. No tools are required.

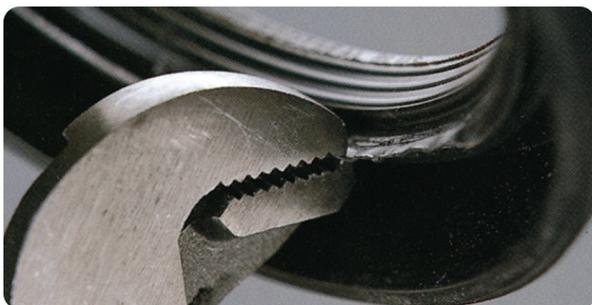
Use pliers to straighten the flange on the sleeve section. Be sure to wear gloves and use a shop rag to protect your hands, as the opened flange is extremely sharp.

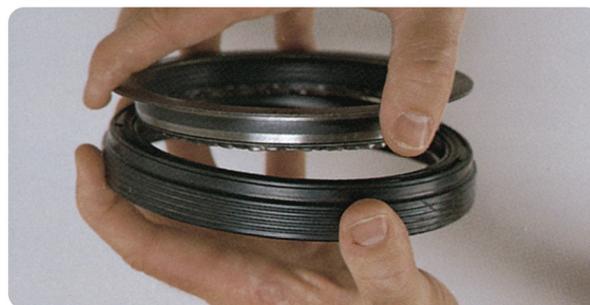
Carefully separate the two components. Then set the seal component aside and carefully review the sleeve component.

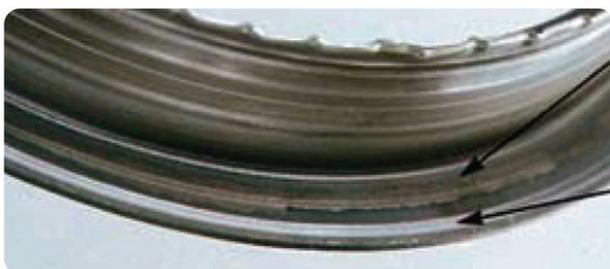
Axial dirt lip pattern

Bumper lip wear pattern

**Good axial and bumper lip patterns:** When you examine the axial face, you have two more wear patterns to learn from. About half way up on the face you should see a pencil line track from the axial lip and at the top edge a gently scuffed pattern from the bumper lip.

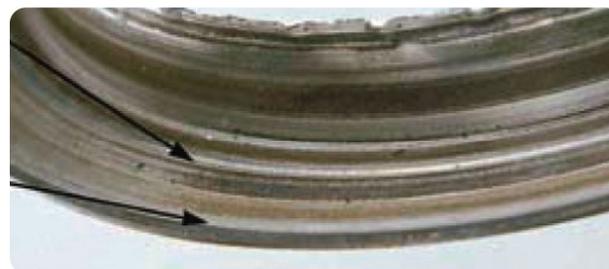
**Wide, shiny:** If both lines are wide or polished clean, you should suspect that the seal has been compressed. This will happen if the I.D. of the seal isn't lubricated before installation, if the sleeve wasn't seated fully on the spindle, or if the bearing adjustment is too tight.

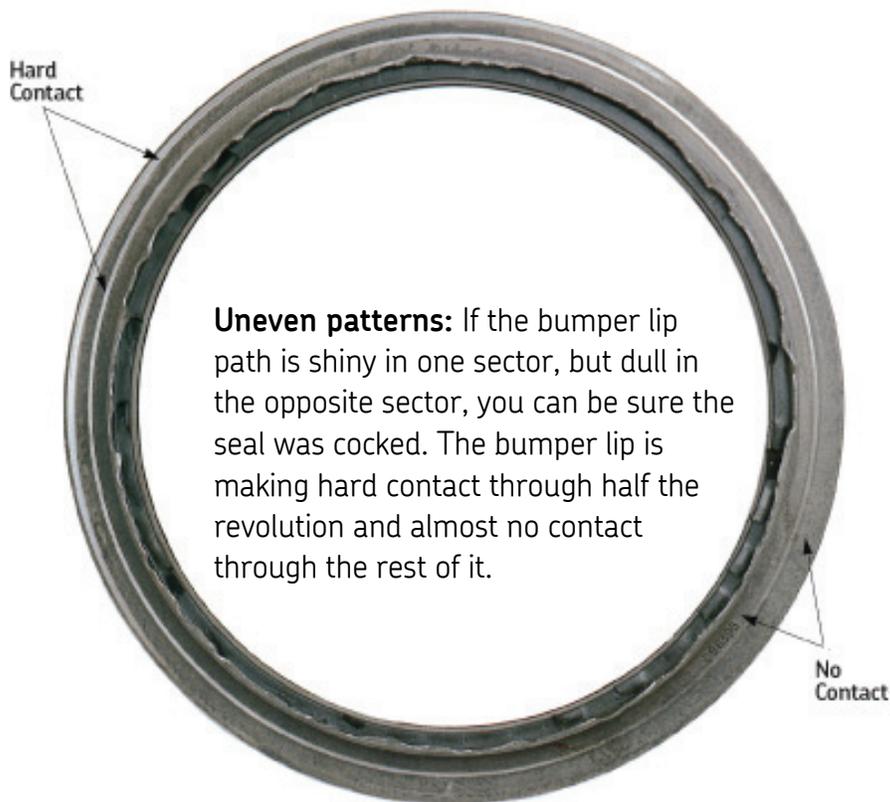
**Uneven patterns:** If the bumper lip path is shiny in one sector, but dull in the opposite sector, you can be sure the seal was cocked. The bumper lip is making hard contact through half the revolution and almost no contact through the rest of it.
