# OrthoWorks

Imaging around MR  
Conditional implants

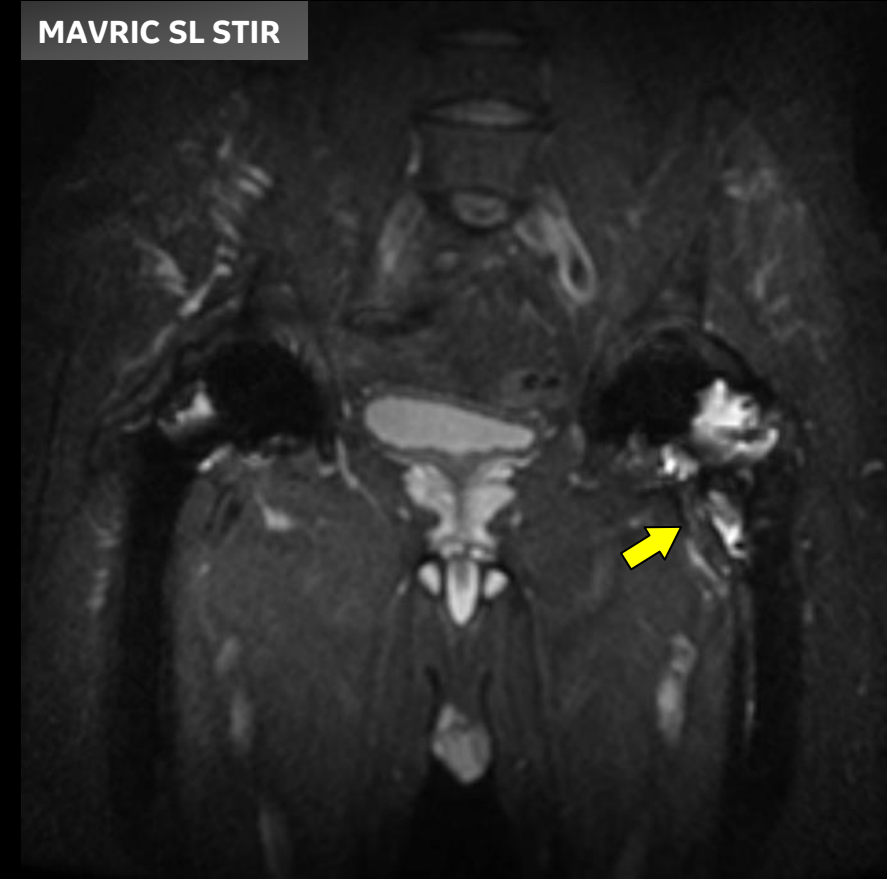
- Mid 50s, 10 years S/P MOP bilateral THA
- [MAVRIC SL](#) PD and STIR indicate signs of polymeric-wear debris
- Patient scheduled for unilateral revision arthroplasty

[MAVRIC SL](#) PD and STIR

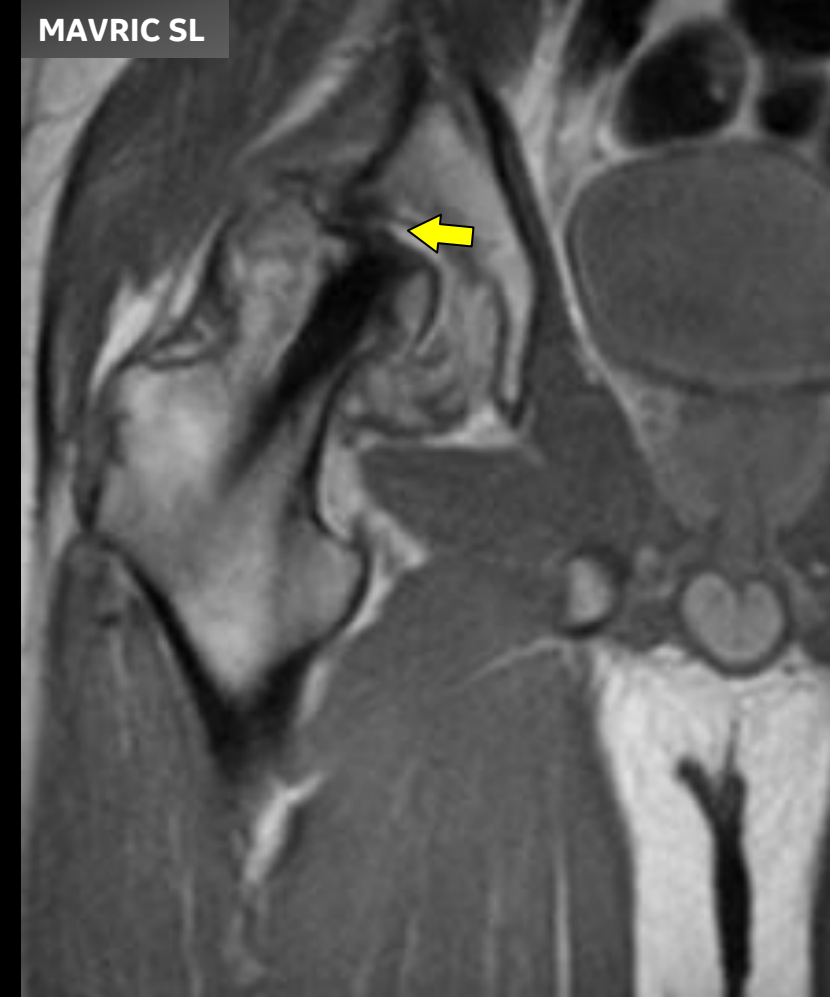
- Late teen with sport-related hip dislocation
- Hip reduction complications led to placement of femoral head fixation screws
- MAVRIC SL shows osteonecrosis with collapse which lead to migration of hardware into the joint (arrow)
- Patient later underwent total joint replacement

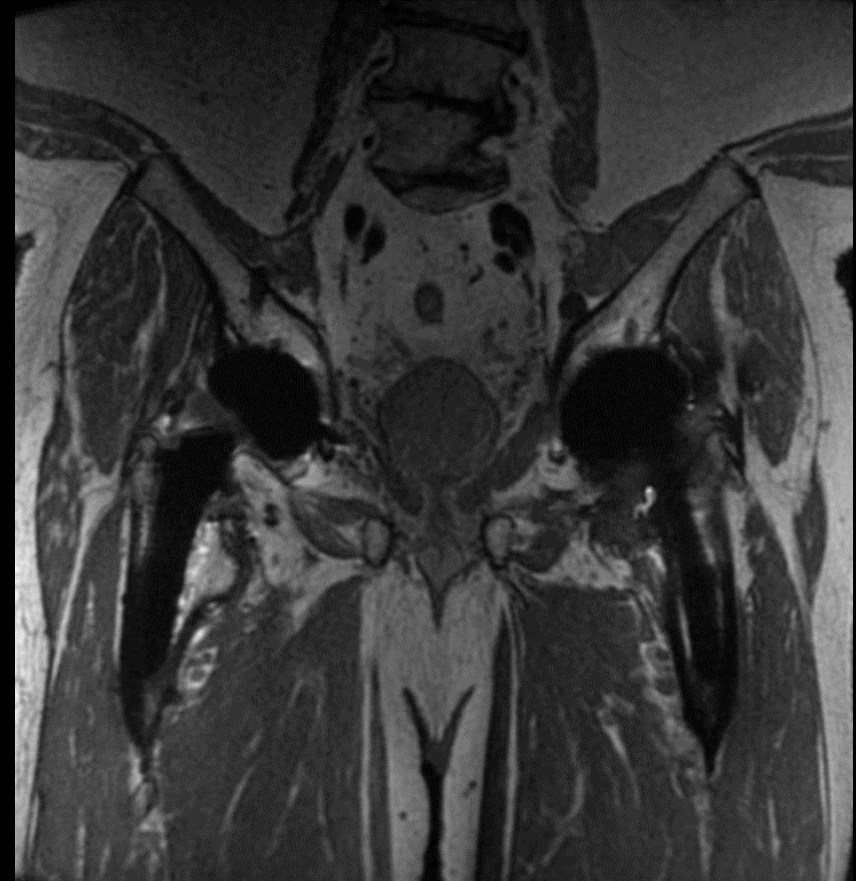
MAVRIC SL PD  
0.4mm x 0.6mm x 4mm
