## SERVICE AND APPLICATION NOTES

100077 March 2, 2023

# Possible Incorrect Wiring Diagram - Certain LRP14HP Units

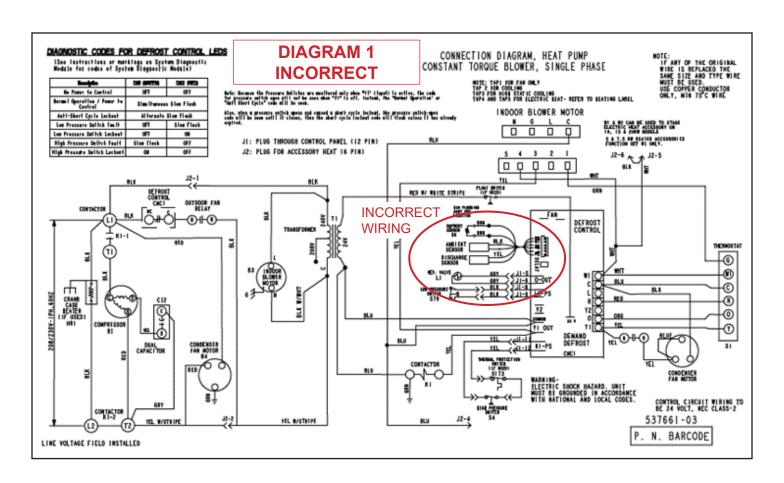
We have been made aware that some of the 3- and 5-ton packaged heat pump units listed above may have been manufactured with the incorrect unit wiring diagram installed (marked as Diagram 1 on following page). The unit wiring diagram label is located on the inside of the heating compartment panel, and is also included in the Installation Instructions. For reference, the following page has examples of both the correct diagram and incorrect wiring diagram.

If you encounter one of the above-referenced packaged heat pump units that has the incorrect wiring diagram installed, please reach out to your Field Technical Consultant and request the correct unit wiring diagram and Installation Instruction.
