V.A.C.®
Therapy

3M™ ActiV.A.C.™ Therapy System Alarm Troubleshooting Guide

Quick reference for the delivery of prescribed therapy.

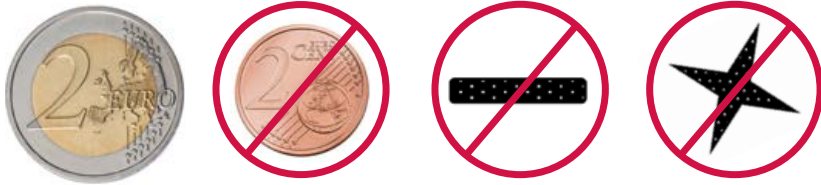
IMPORTANT! To help optimize performance of the SensaT.R.A.C. Pad, you must cut a 2.5cm hole in the dressing. A smaller hole, an “x” or a slit may cause blockage, pressure fluctuations and other functionality issues. This can prevent delivery of prescribed therapy and cost caregivers valuable time.

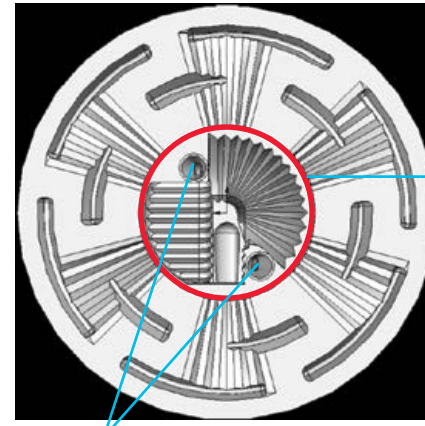
2.5cm size hole

Sensing Lumens

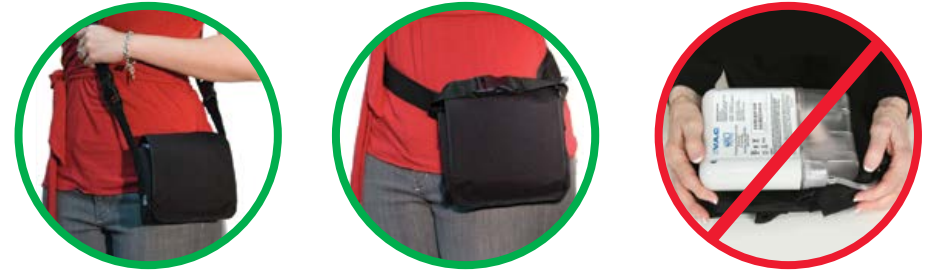
Optimal Orientation

To help minimize canister alarms when not being worn, maintain the unit in an upright position. Avoid placing therapy unit upside down (with touchscreen facing down).
