Clinical Success with 3M™ Express™ XT VPS Impression Material.

Jesús Espinosa, DDS
Mexico

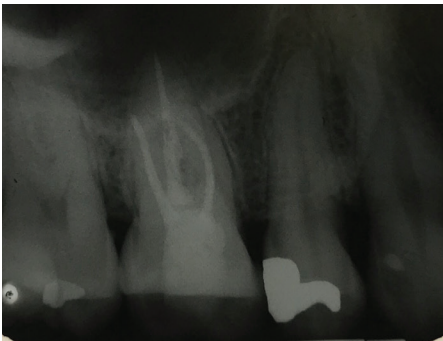
Fig. 1: Tooth #16 exhibited a failed inlay that led to a root canal treatment. Note the thin walls on the X-ray.

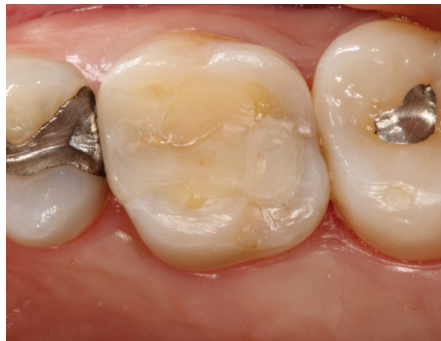
Fig. 2: Occlusal view of the adjacent teeth, with sealed amalgam restorations.

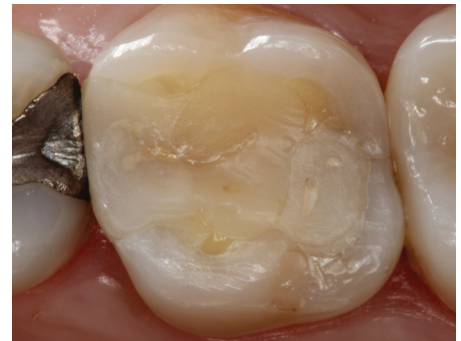
Fig. 3: Close-up of the failed restoration. Notice the porcelain inlay with thin walls on the working cusps. Composite was used to seal the root canal treatment.

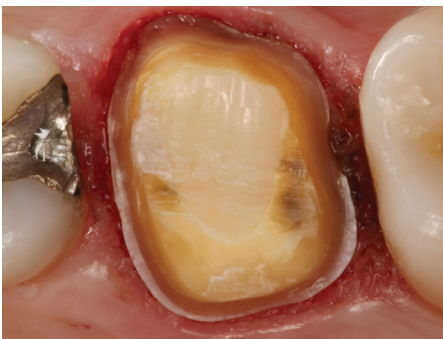
Fig. 4: Anatomic reduction, a defined chamfer margin and adequate axial and occlusal reduction is necessary so the technician can build a natural anatomic crown.

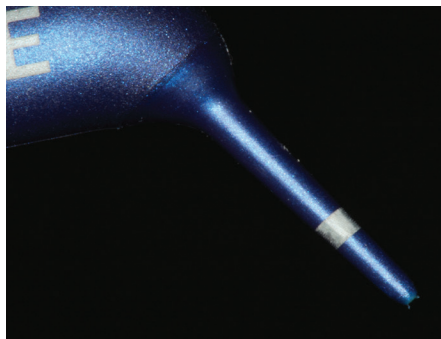
Fig. 5: 3M™ Astringent Retraction Paste was used. The rounded and 3mm marked tip allows the reliable delivery of the retraction paste into the sulcus.

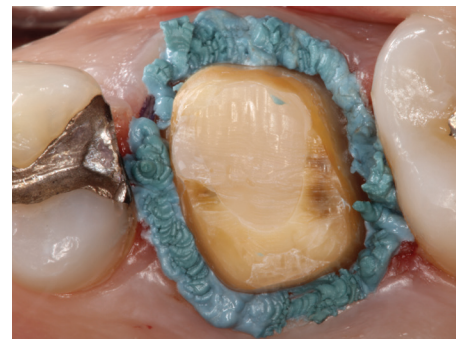
Fig. 6: The retraction paste was placed around the tooth and left in situ for 2 minutes.

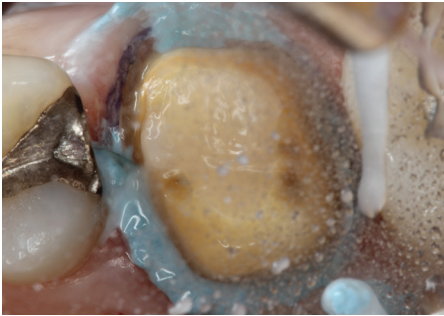
Fig. 7: The retraction paste is easily removed with an air water syringe.

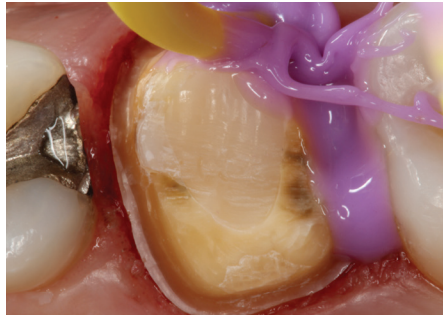
Fig. 8: 3M™ Express™ XT Light Body VPS impression material was placed slowly around the margin, avoiding air bubbles. Notice that there is no bleeding and that the gingival tissue is away from the preparation.

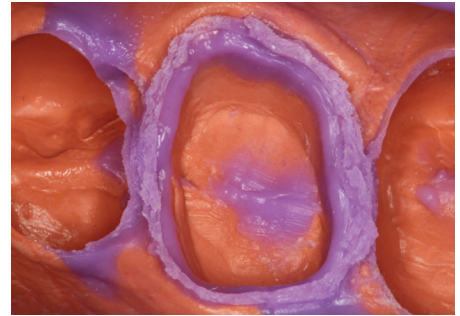
Fig. 9: Occlusal view of the impression — notice the marginal detail.

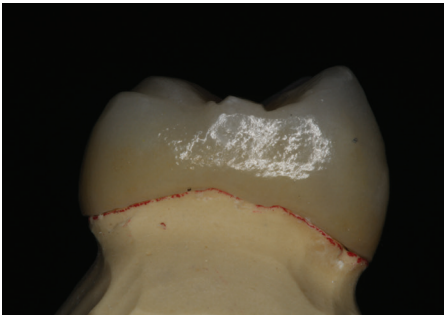
Fig. 10: The fit of the veneered zirconia restoration was checked on the die. The inner surface was sandblasted with Al_2O_3 , 50 microns at 30 PSI and then cleaned with alcohol to create microretention.

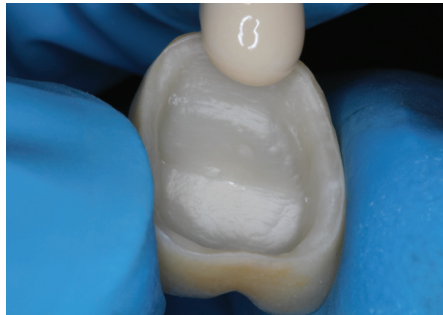
Fig. 11: 3M™ RelyX™ U200 Self-adhesive Resin Cement was used for this case, in my opinion this is the best option for zirconia restorations.

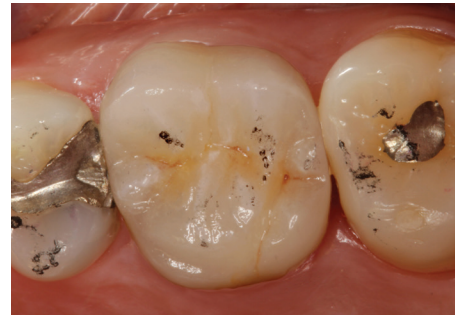
Fig. 12: After the excess resin cement was removed, the occlusion was checked.
