Reliable PFM crown cementation simplified with easy tack cure clean-up

A case study by Dr. Robert Margeas, DDS featuring 3M™ RelyX™ Luting Plus Resin Modified Glass Ionomer Cement

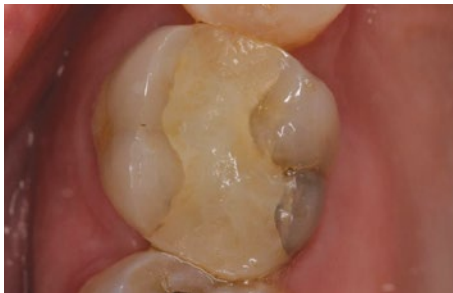
The patient presented to the office with pain on biting of his upper left first molar (tooth #14). The tooth had a large composite restoration and a crack going from mesial to distal. The old restoration was removed and a new build up was placed. The tooth was prepared for a full coverage PFM restoration. When doing either PFM or Zirconia restorations, I always use resin modified glass ionomer cement due to the ease of use, the retention and the easy clean up.

Fig. 1: The tooth had a large composite restoration and a crack going from mesial to distal.

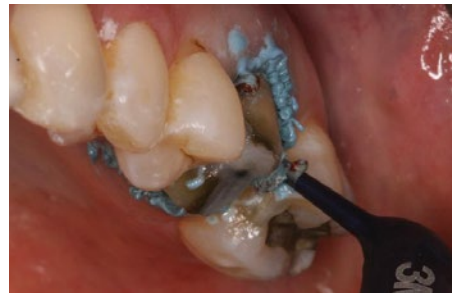
Fig. 2: Prior to making the final impression a small retraction cord was placed.

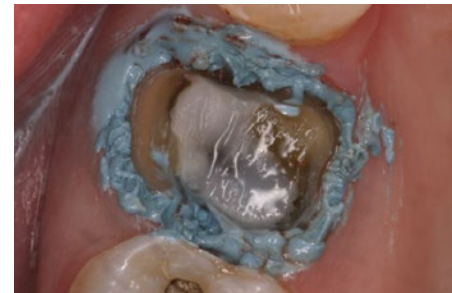
Fig. 3: Then, retraction paste was injected into the sulcus to deflect the tissue and stop any bleeding (3M™ Retraction Capsule).

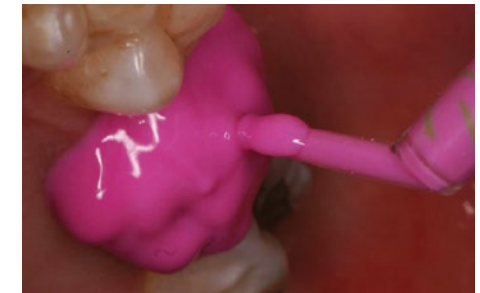
Fig. 4: 3M™ Imprint™ 4 Light Body VPS Impression Material was then applied to the preparation and 3M™ Imprint™ 4 Heavy Body VPS Impression Material was injected into a quadrant tray and placed into the patient's mouth.

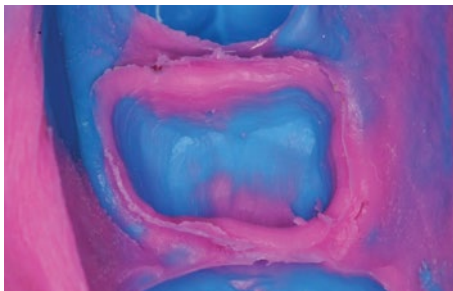
Fig. 5: The final impression.

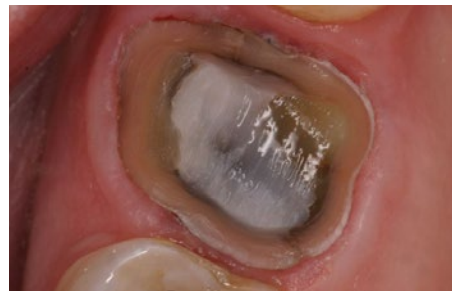
Fig. 6: The tooth was then cleaned.

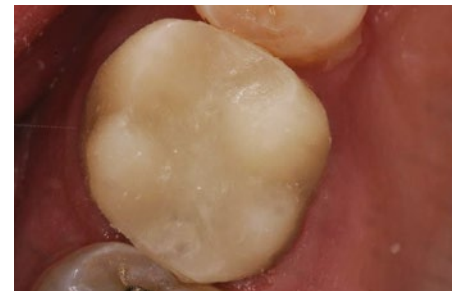
Fig. 7: Following cleaning, a provisional was made out of 3M™ Protemp™ Plus Temporization Material and was cemented with temporary cement. The patient was dismissed for two weeks.

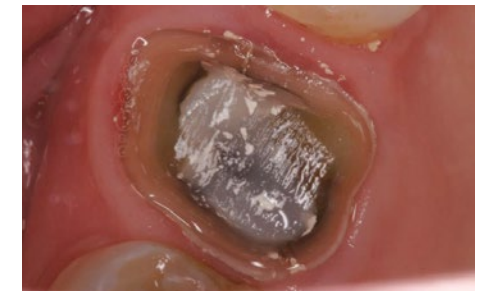
Fig. 8: Once the crown was made by the dental lab, the provisional was removed, the tooth mechanically cleaned, and the PFM was tried in for marginal integrity and contacts.

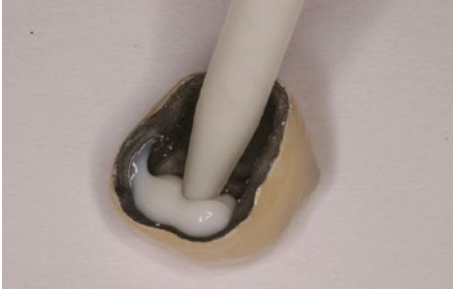
Fig. 9: 3M™ RelyX™ Luting Plus Resin Modified Glass Ionomer Cement was injected into the crown utilizing the automix syringe delivery.

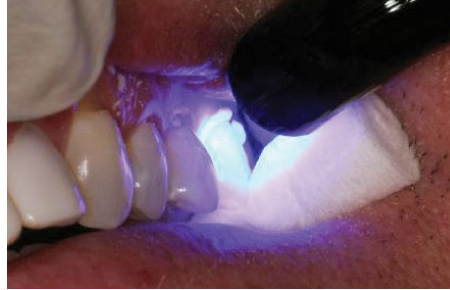
Fig. 10: The crown was firmly placed over the preparation. The margins were then cured for five seconds utilizing the 3M™ Elipar™ DeepCure-S LED Curing Light.

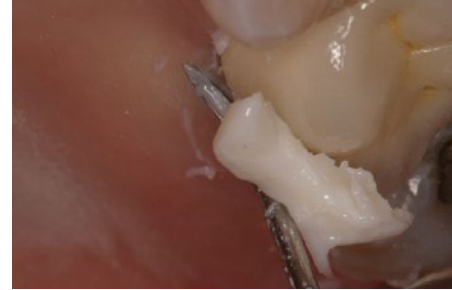
Fig. 11: The cement around the margins was easily peeled away.

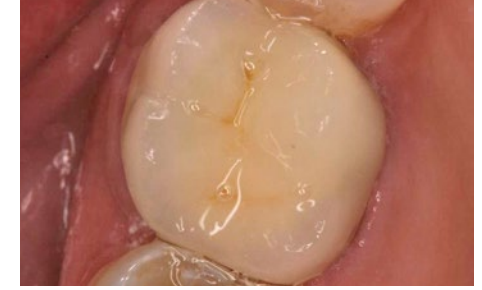
Fig. 12: The patient was instructed to bite on a cotton roll for five minutes. The final restoration.
