# V.A.C. Dermatac™ Drape

## 3M™ V.A.C. Dermatac™ Drape with 3M™ V.A.C.® Therapy case studies

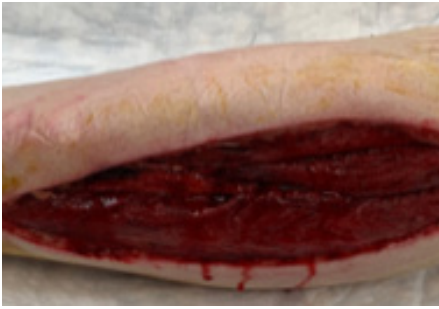
**Figure 1**  
Left lateral calf at presentation  
(20cm x 12cm x 0.1cm).

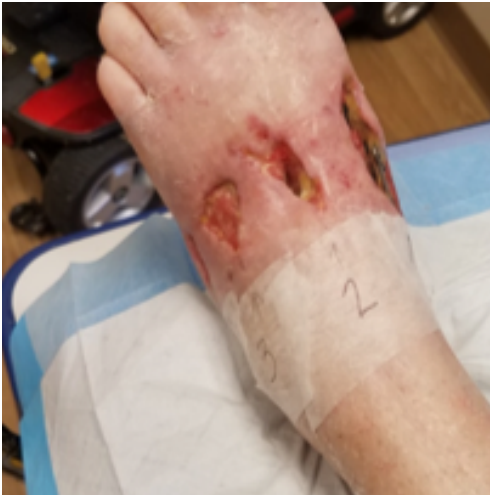
**Figure 1**  
Dehiscent wounds after debridement, 1 week of 3M™ Veraflo™ Therapy with standard drape, and 1 week of 3M™ V.A.C.® Therapy with 3M™ V.A.C. Dermatac™ Drape.
