SERVICE AND APPLICATION NOTES

100046

April 20, 2022

LRP16HP Residential Package Units – 9-Pin Relay Mis-Wiring Issue

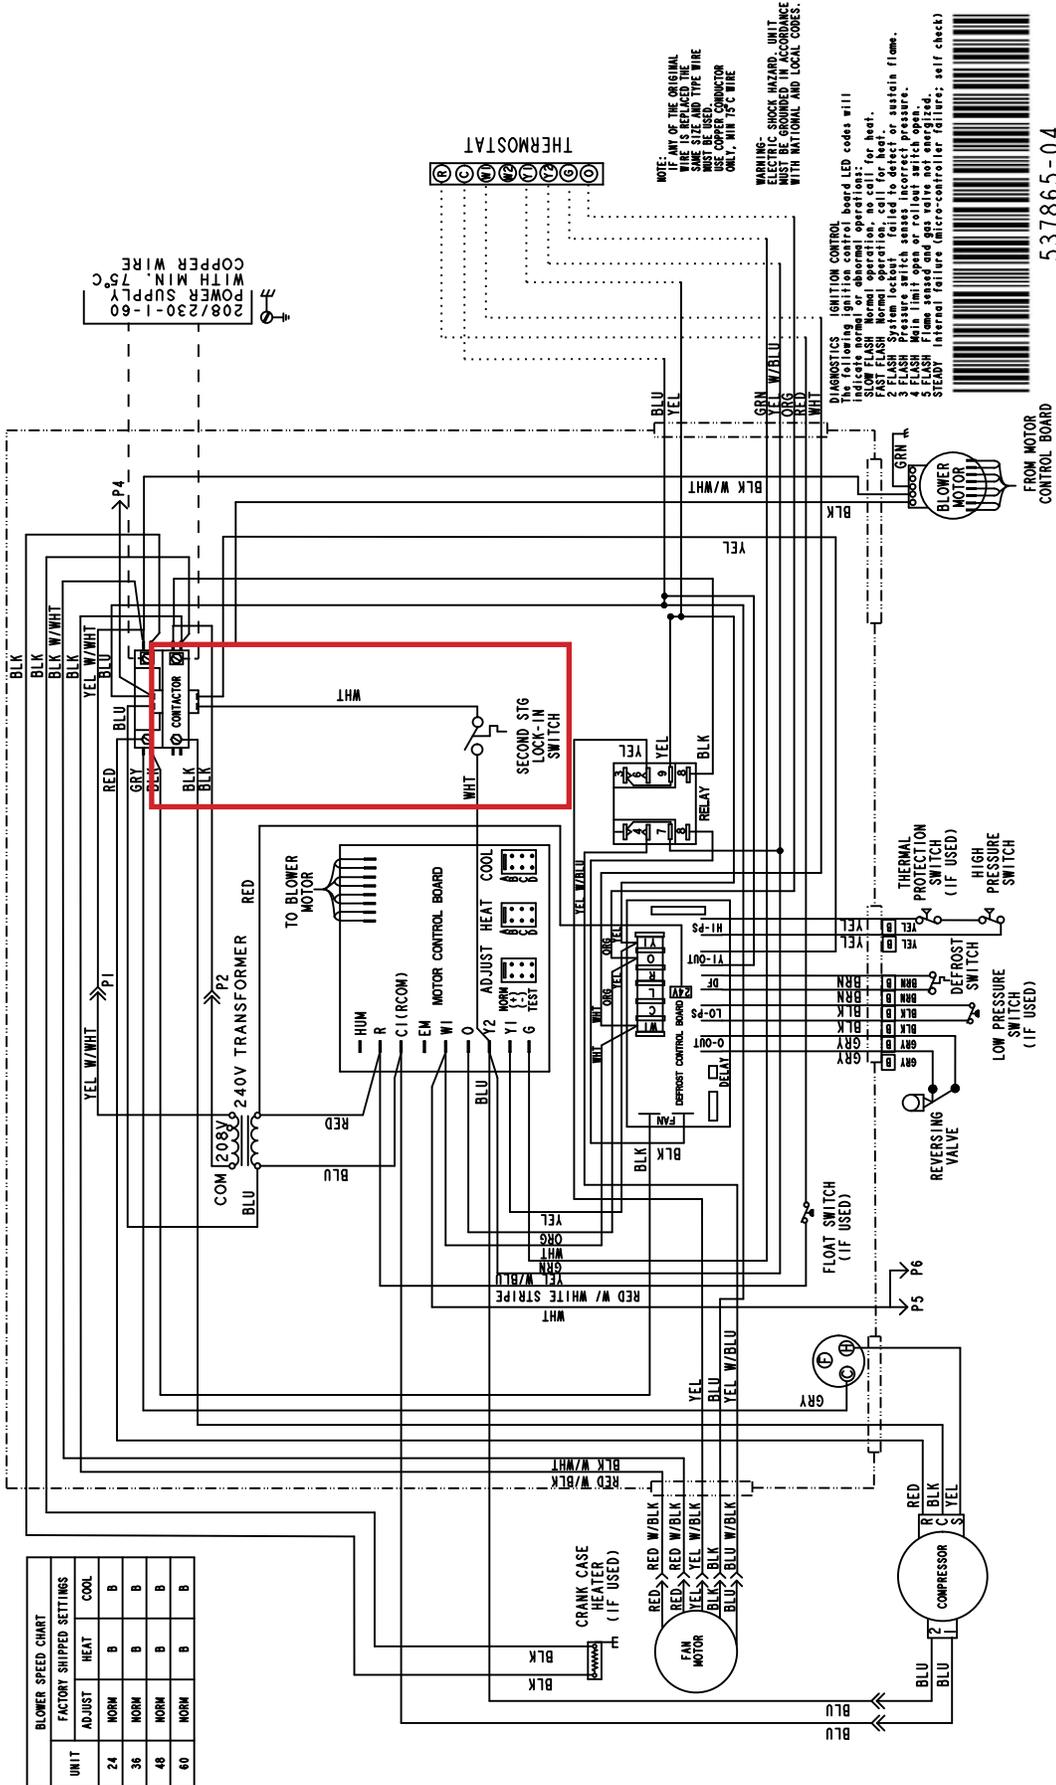
Field / Factory Correction Wiring

There have been some field reports of the clear 9-pin defrost relay being mis-wired from the factory, with the yellow wires reversed on pins # 6 and # 9 in relation to the white two-stage wire attached to pin # 9.

This will cause the outdoor condenser fan to stay on during defrost, and does not allow the second stage to lock in.

The Y2 lock-in switch, previously mis-labeled "LOCK-OUT SWITCH", is designed to lock in Y2 stage compressor operation during the heating mode when the outdoor coil temp is at or below 30°F and opens at around 40°F ± 5°F.

To correct the issue, the factory will move the white lock-in switch wire from pin 9 on the defrost relay to the 24V 'hot' side of the compressor contactor. This will be the same connection point on the contactor as the yellow "Y1-OUT" wire that originates from the defrost control.

For units already installed, the field can cut off the 3/16" spade terminal from the white wire and install a 1/4" spade terminal and install it on the compressor contactor 24V 'hot' terminal with yellow wire Y1 out that comes from the defrost board.
