Second Sight TC® Remote Gas Detection System Provides Additional Layer of Plant Protection

MARCH 2011

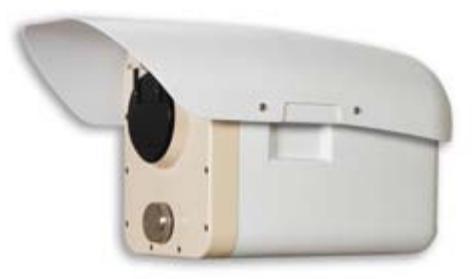
Our newest gas detector, the advanced Second Sight TC Remote Gas Detection System uses high resolution infrared imaging to add another layer of safety to the detection of combustible

Second Sight TC, developed by Bertin Technologies, is designed for ease of use, with a human machine interface (HMI) that permits operators to see target gases in real time as they are detected by the IR camera. A video image displays overlaid levels of gas concentrations to provide a unique picture of gas dispersal. Personnel are able to efficiently address the source of leaks and respond to alarms based on the type of gas and the size, direction, and speed of evolution of the gas cloud. With the HMI, users can deselect areas within the imager's field of view that are not of interest or may contain potential sources of false alarm.

Second Sight is a gross leak detector that can simultaneously detect up to four different gases. It features a wide field of view (30° standard) and a maximum detection range of 2 km for continuous monitoring of critical areas. Detection sensitivities are verified for quantities of hydrocarbon gas of approximately 2 kg at 250 m.

The reliable, low-maintenance Second Sight System features a long wave infrared (LWIR) camera with a spectral range of 8-14 μ m (IR) at a spatial resolution of 384 x 272 pixels. The camera has a standard maximum range of 3,281 ft (1,000 m) and an optional range of up to 6,562 ft (2,000 m). It can detect methane at 0.1 LEL-m, propylene at 0.1 LEL-m, butane at 0.3 LEL-m, and propane at 0.5 LEL-m. It operates at a temperature range of 14° to 131°F (-10° to 55°C) and humidity range of 0-95% RH, non-condensing.
