NAPA Tech TIPS

Transfer Case Motor Typical Failures and Prevention

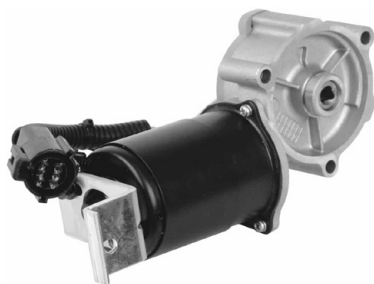
Typical Ford Motor

Ford applications require transfer of wire connector pins. Be sure to record pin location before removing the original unit.

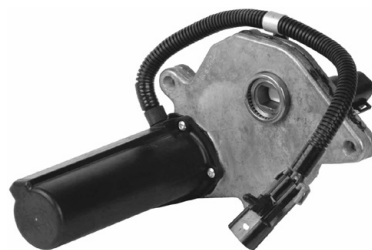
Typical GM Motor

Replacement motors for GM vehicles are supplied in 2-wheel drive position. If necessary, select or move transfer case into 2-wheel drive before installation of replacement motor. GM applications will require a scan tool to clear the codes from the transmission control module (refer to the vehicle service manual for correct tool and procedures).
