Tech TIPS

Don't Let the Power Steering Snake Bite You

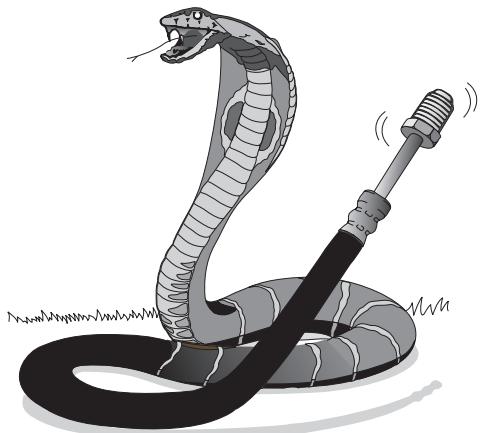
During installation of the replacement unit carefully inspect the hydraulic hoses. Hoses that appear harmless may have hidden problems. They deteriorate from the inside out, passing contamination throughout the entire system. This results in premature failure of the steering system. **ALWAYS FLUSH THE ENTIRE SYSTEM AND REPLACE HOSES TO PREVENT WARRANTY PROBLEMS.**

**FAILURE TO REPLACE
HOSES COULD COME
BACK TO BITE YOU!**
