Agricultural adapter bearing installation

Tech tip

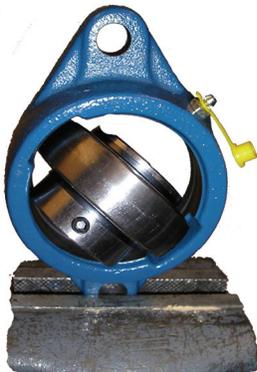
Figure 1

- Mount the flanged housing in a vise, (figure 1) and insert the adapter bearing into the visible "slots" on the casting until it lightly pressfits to both sides of the housing.
- Rotate the adapter bearing into the casting bore by turning it a total of 90 degrees to the proper operating position. (figure 2)
- Bolt flanged housing securely to the support. **Note:** If the adapter bearing fails to properly seat in the casting (I.E. it is too tight to seat or, too loose to prevent outer ring rotation), check adapter and bore for debris that may be causing the binding or make sure the bearing and housing are of the proper fit. Another adapter bearing or flanged housing combination may be necessary.
