Safety Notice

Calgaz[™] Calibration Gas – Econo-Cal Cylinders

October 28, 2016

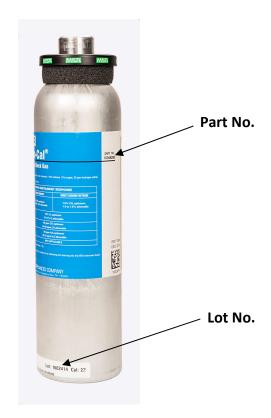
Affected cylinders are missing DOT information imprinted on the bottom of the cylinder as illustrated below:

- Cylinder is one of the Part No's and associated Lot No's listed above,
- Cylinder is missing the DOT information on the bottom, as indicated in the photo above.

Although affected cylinders must not be distributed or used, Calgaz advised that they received a written statement from the cylinder manufacturer stating that they are confident in the safe operation of this nonconforming cylinder at a fill pressure of 500 psi. The manufacturer has based its statement upon the cylinder sidewall thickness as produced and burst test pressure in excess of 1500 psi.

If you have any affected cylinders, the best course of action is to quarantine them and follow the attached guidelines titled: **Handling Instructions for 2AL Cylinders**.

To obtain replacement cylinders, please complete the attached order form and email it to MSA Customer Service at the appropriate email address indicated below. MSA will immediately ship the replacement calibration gas cylinders to you free of charge.
