## User Notice PS-MaXX Adapter

April, 2023

MSA is issuing this User Notice to inform you of an additional inspection procedure regarding usage of the PS-MaXX adapter.

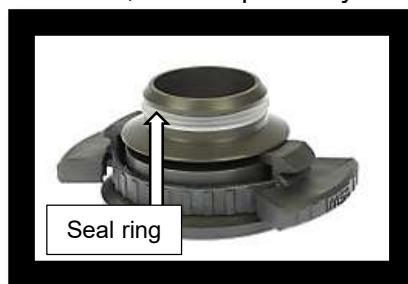
MSA has received a report of a broken white seal ring used on a PS-MaXX adapter in conjunction with a G1 facepiece. A broken seal ring may result in potential exposure to the ambient atmosphere of the user. **MSA has only received one report of this condition. However, it is necessary that you perform the actions outlined in this notice.**

1. If connected to a G1 facepiece, disconnect the PS-MaXX adapter from facepiece.
2. Visually inspect the white sealing of the adapter for any visual imperfections (figure 1)
  - a. If any visual damage is found, remove the unit from service, quarantine the unit, and contact MSA for a replacement sealing.
  - b. If no visual damage is found, the adapter may be returned to service.

Figure 1 – PS-MaXX adapter and seal ring

This inspection procedure must be performed on your entire stock upon receipt of this notice and prior to each connection of the PS-MaXX adapter to the facepiece, for continued proper operation of the white seal ring.

MSA has also updated the PS-MaXX instruction sheet (10042489) to include inspection of the sealring and adapter, available here: ([Instruction Sheet for Filter Connection PS-MaXX](#)). Please download and replace your manuals with the latest update. This inspection must be performed prior to each connection of the PS-MaXX adapter to the facepiece.
