# Product Information News

## Monthly Tightness Inspection of Quick-Fill® System and URC Couplings

### To: Users of Air Masks Equipped with a Universal Rescue Connection Coupling

#### User Notice Universal Rescue Connection July 17, 2008

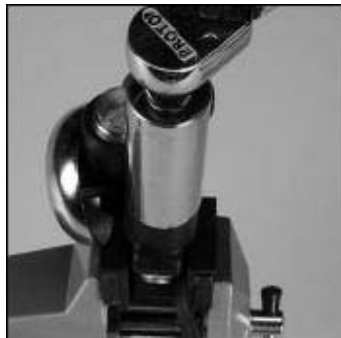
#### Installing Quick-Fill/URC Coupling

1. Install a new URC Coupling
  - a. Secure the Quick-Fill manifold or Audi-Larm block in a vise.

2. Screw the coupling into the manifold/alarm body by hand.

3. Use a torque wrench and 1" **deep-well socket** to tighten to **70–75 ft lbs.**
