# Precise imaging in severe cardiomegaly with single ventricle

Courtesy of Ferran Rosés, MD, MSc, PhD, Head of the Pediatric Cardiology Department at Vall d'Hebron University Hospital in Barcelona, Spain

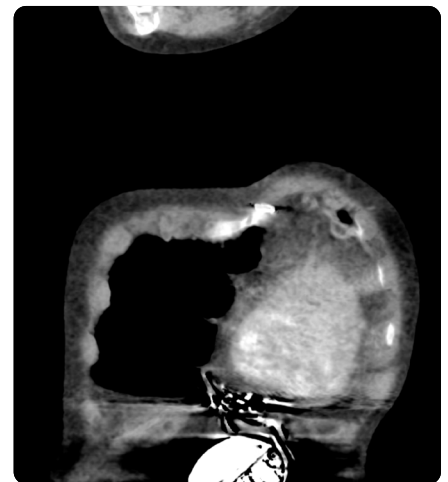
CT scanner showing single ventricle and pacemaker

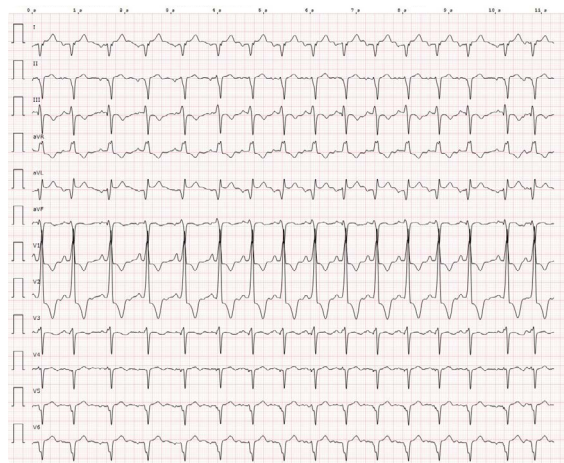
12 Lead ECG post CRTP: QRSd 151 ms
